BENTHIC ASSESSMENT OF CANALS IN PHASE 1B

January 15, 2018

JOHNSON
ENGINEERING

Phase 1B: Tape Grass Restoration Benthic Sampling
Johnson Engineering Inc. Ft. Myers, FL
January 15, 2018

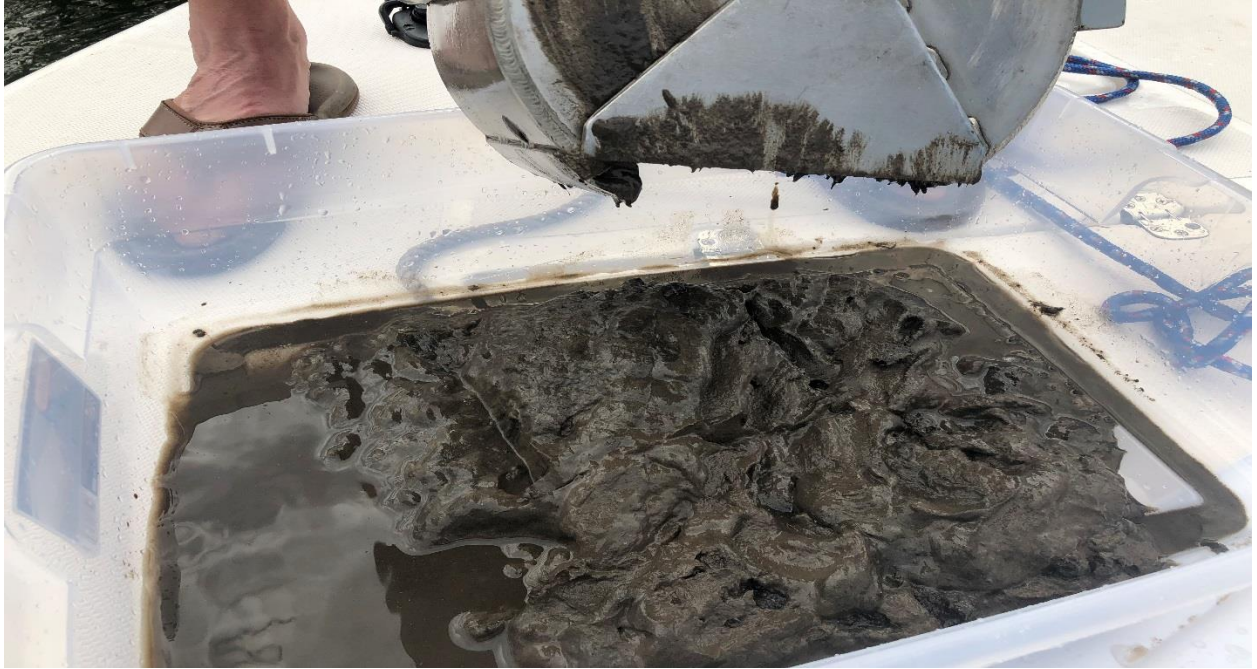
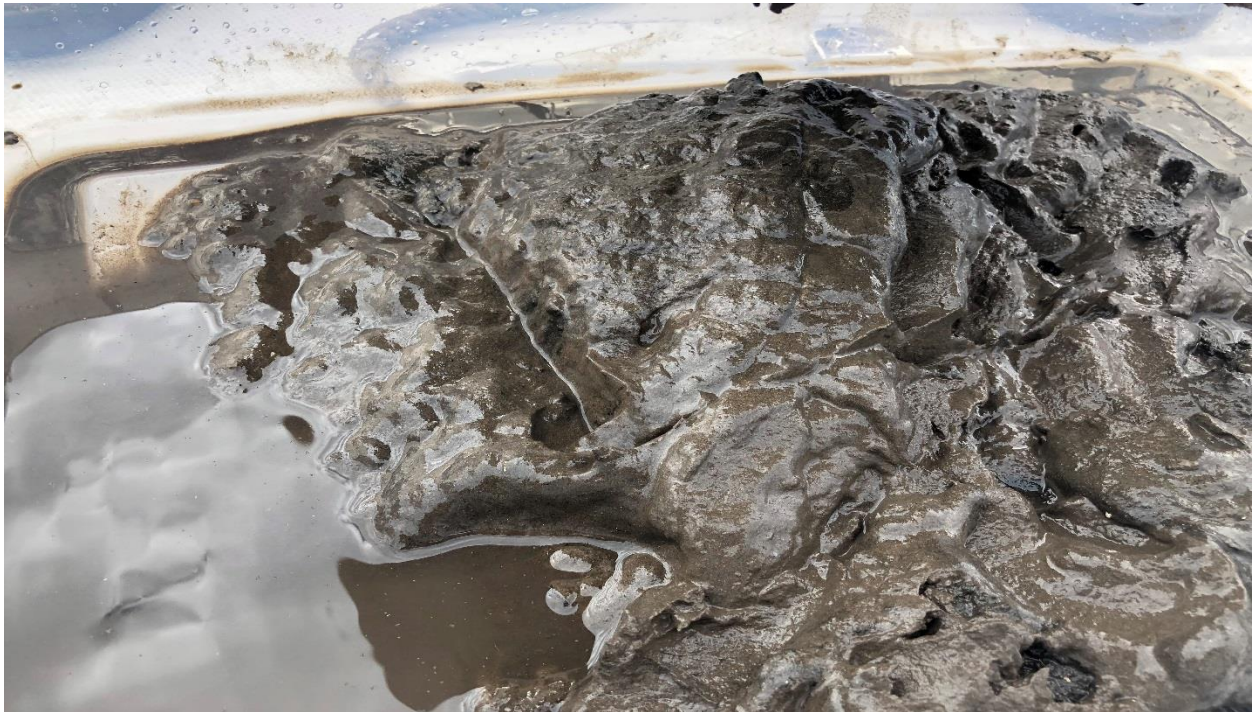
Site 1B control 1. N: 28.5327 W: -82.3526. Depth - 5.0'

Petite Ponar dredge samples from the unrestored “control” section of the main canal contained 95%, 95% and 90% mud/muck for C1, C2, and C3 respectively. C1 also contained approximately 4% sand and 1% clay. C2 and C3 also contained about 5% *Lyngbya* and C3 also contained 5% shell material from dead snails. The deep mud/muck content was consistent in unrestored areas and mostly unconsolidated with anoxic odor indicators (methane or sulfide). Depths of mud/muck were not quantified in this assessment

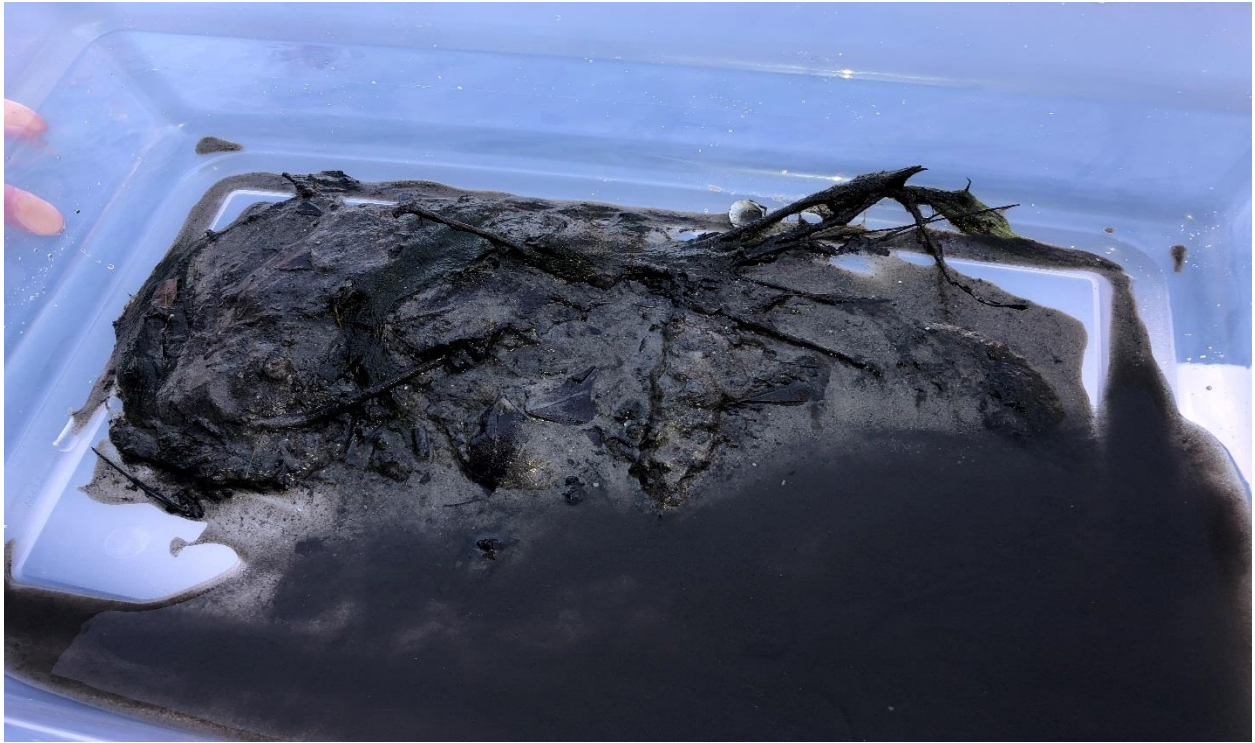
Site 1BE6. N: 28.5318 W: -82.3509. Depth - 6.5'

The easternmost canal (Canal 1) had an average depth of 4.7 feet based on our ten samples collected. Canal 1 contained an average of 43% mud/muck with content ranging from 0-90% (Table 1). Two samples (1BE6 and 1BE7) contained 90% mud/muck with a depth of at least 10 cm, but no *Lyngbya* was found in these samples. Sample 1BE8 contained 85% mud/muck, 10% sand, and approximately 5% *Lyngbya*. Sand content averaged 41% with content ranging from 2-90%. Rock was dominant with 95% content at one location where there appeared to be a small vent. Small amounts of clay, shell, woody debris were also found at some locations. A *Vallisneria americana* planting unit was incidentally collected by petite Ponar at 1BE9 while southern naiad (*Najas* sp.) was collected at 1BE10. Overall, the sediments in the eastern canal (Canal 1) were considered suitable for *Vallisneria americana* planting units with the possible exception of three locations with 85-90% mud/muck in the middle area of the eastern canal. These locations were deeper than most of the other sites and it appears that these three samples with 85-90% mud/muck represent a section of the canal that was missed in the de-mucking process. Video of this area (attached) in Canal 1 also show relatively high *Lyngbya* cover compared to other areas in Phase 1B.

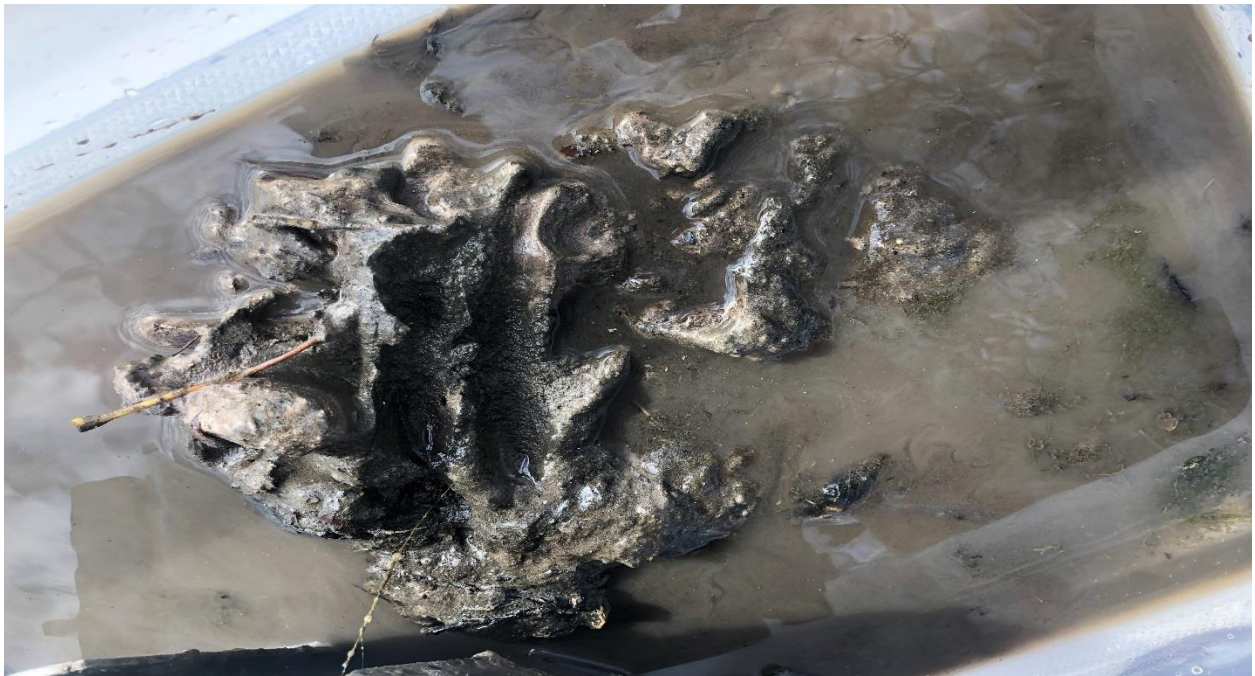
Site 1BW6. N: 28.5320 W: -82.3529. Depth - 9.2' (upwelling)

1B W6 = new warmwater spring
