ANNUAL MONITORING REPORT (1 OF 3)

SAVE CRYSTAL RIVER PILOT PLANTING
REPORT

FDEP PERMIT NUMBER: 09-0332123-001

Carter Henne
Sea and Shoreline, llc.
4331 Cockroach Bay Rd
Ruskin Fl, 33570

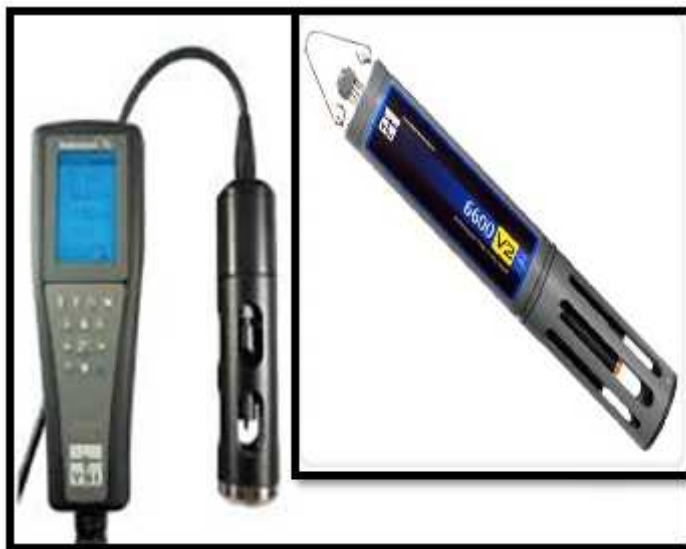
Figure 3. YSI Professional Plus multi-parameter water quality logger. Inset – YSI 6600 V2 Sonde

using a calibrated YSI 6600 V2 sonde or a YSI Professional Plus multi-parameter water quality logger (Figure 3). The water quality values for each individual parameter at each depth are reported as mean values for the two stations at the planted and reference sites, respectively. Water quality measurements were further evaluated for compliance with DEP/EPA Standards for environmental protection.

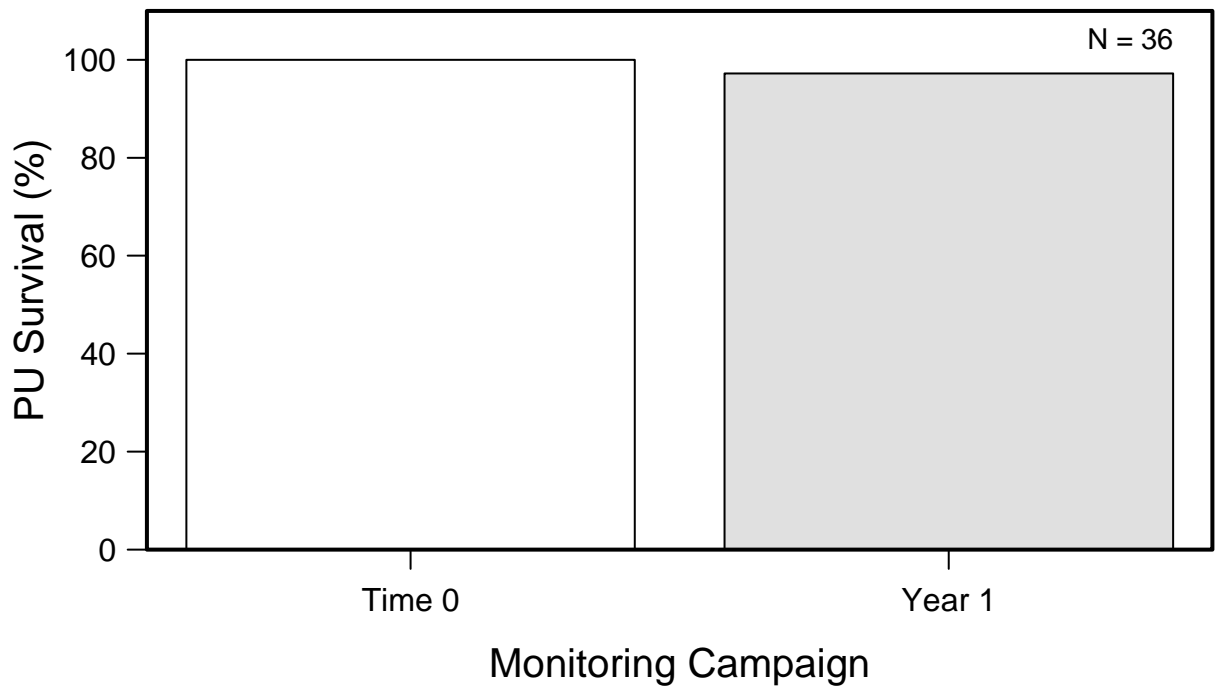
During this 1st monitoring campaign, 5 months post-planting, survival of planted cages was 97.2% (Figure 4)..

Figure 4. Survival of *V. americana* PUs during Campaign 1.

The results of this first monitoring campaign indicated that nearly the entire PU deployment survived the transplanting process (97% survival). This survival rate is better than the average global success rate for transplanting seagrasses, considered to be 50% (Fonseca et al. 1998). The initial biological response of transplanted *V. americana* indicate that the relocation methods were successful in alleviating undue stress and, at one year, the survival rate of relocated plants exceeds the target rate of 80%.

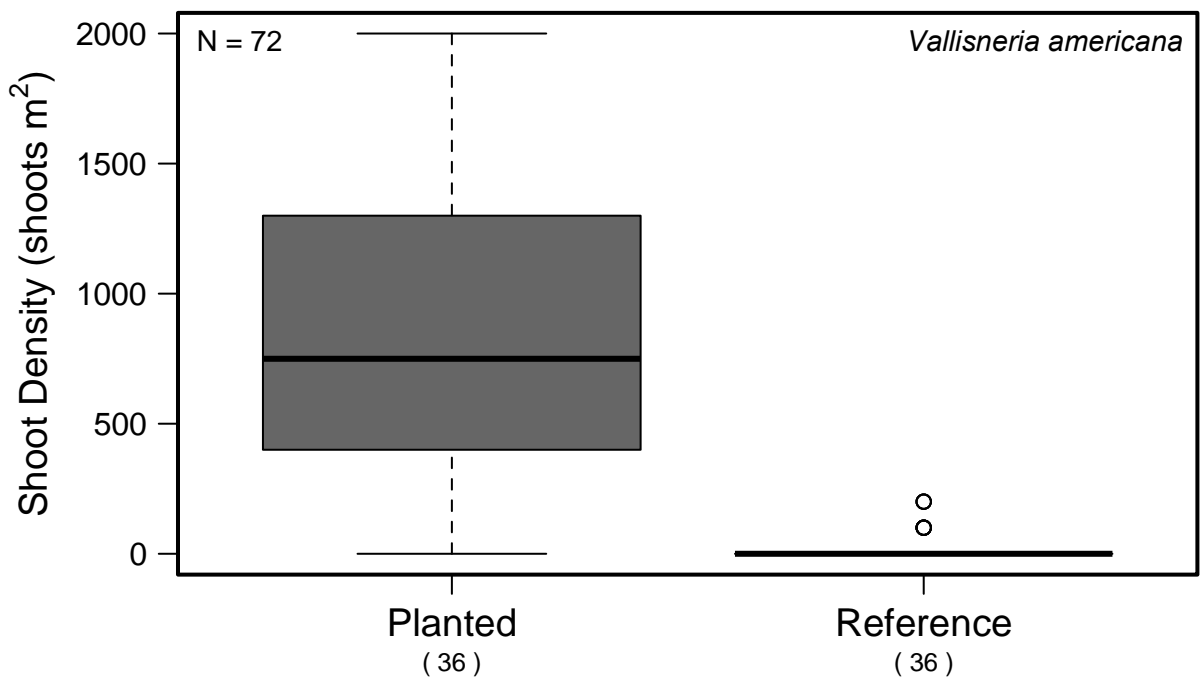
V. americana was observed in both the planted and reference sites (Figure 5). Shoot densities within the planted zone were highly variable, ranging from 0 to 2000 shoots m⁻² with a mean (+/- 1 s.d.) value of 867 +/- 549 shoots m⁻². Reference densities were considerably lower at 31 +/- 62 shoots m⁻² with a range of only 0 to 200.

Figure 5. Boxplot of *Vallisneria americana* shoot density (shoots/m²) at the reference and relocation sites during Campaign 1.

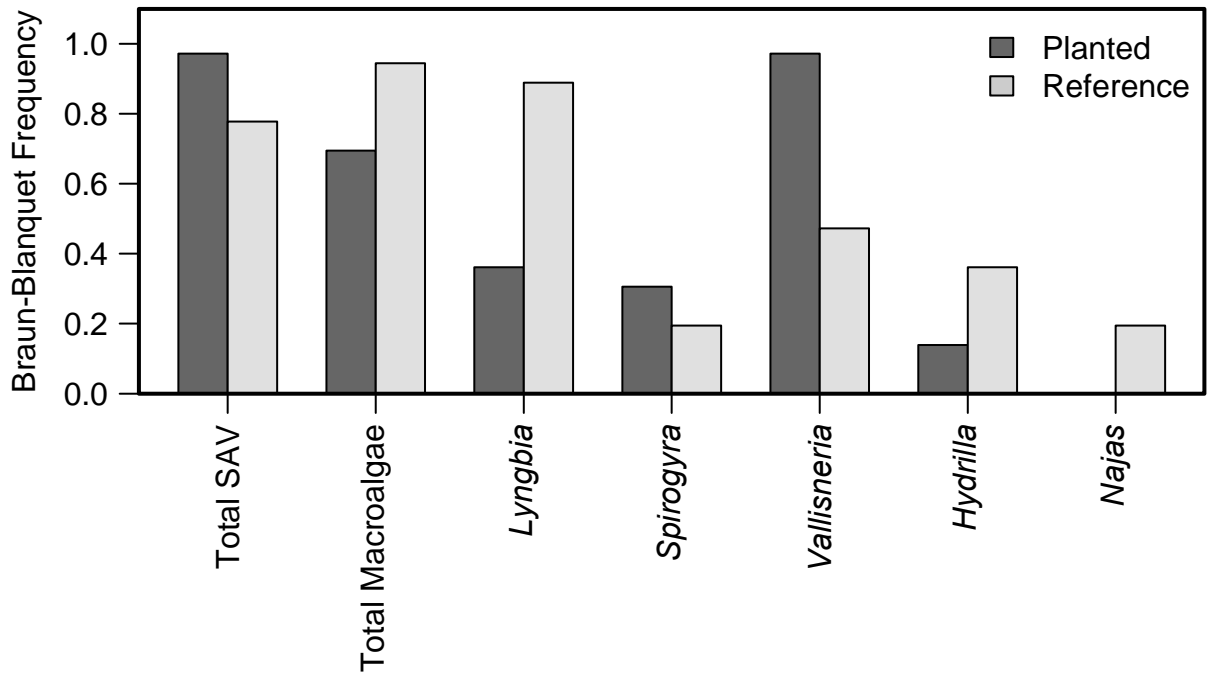
In Campaign 1, the frequency of total SAV was higher (0.97, planted; 0.78, reference) and total macroalgae lower (0.69, planted; 0.94, reference) in the planted versus the reference sites (Figure 6). *Lyngbia* was more than half (0.41 x) as frequent in the planting area than adjacent reference locations, while the transplanted species, *V. americana* was 2.06 times more frequent. Interestingly, the other two SAV species: *Hydrilla* and *Najas* were less abundant in the planted cages (0.14 and 0.00, respectively) than references (0.36 and 0.19, respectively).

Figure 6. Braun-Blanquet frequencies for SAV and algal species at the planted and reference sites

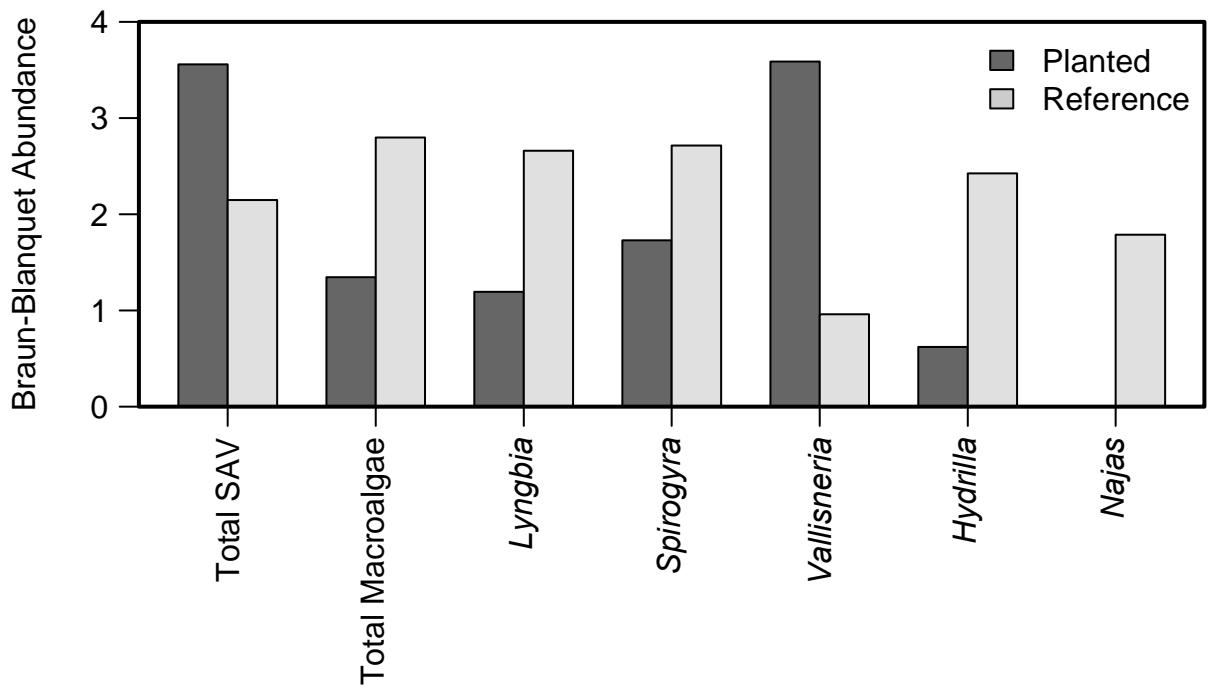
In the quadrats occupied *V. americana* in campaign 1, abundance values were higher in the relocation sites (3.48) than in the reference sites (0.95; Figure 7). Total SAV abundance was also higher in the relocation (3.56) than the reference sites (2.15), while total macroalgae was lower (1.34 and 2.80, respectively). Within the macroalgae community, *Spirogyra* was less abundant (1.73 vs. 2.71) despite being more frequently recorded in planted rather than reference quadrats. Overall, however, frequency and abundance patterns were similar.

Figure 7. Braun-Blanquet abundances for SAV and algal species at the planted and reference sites

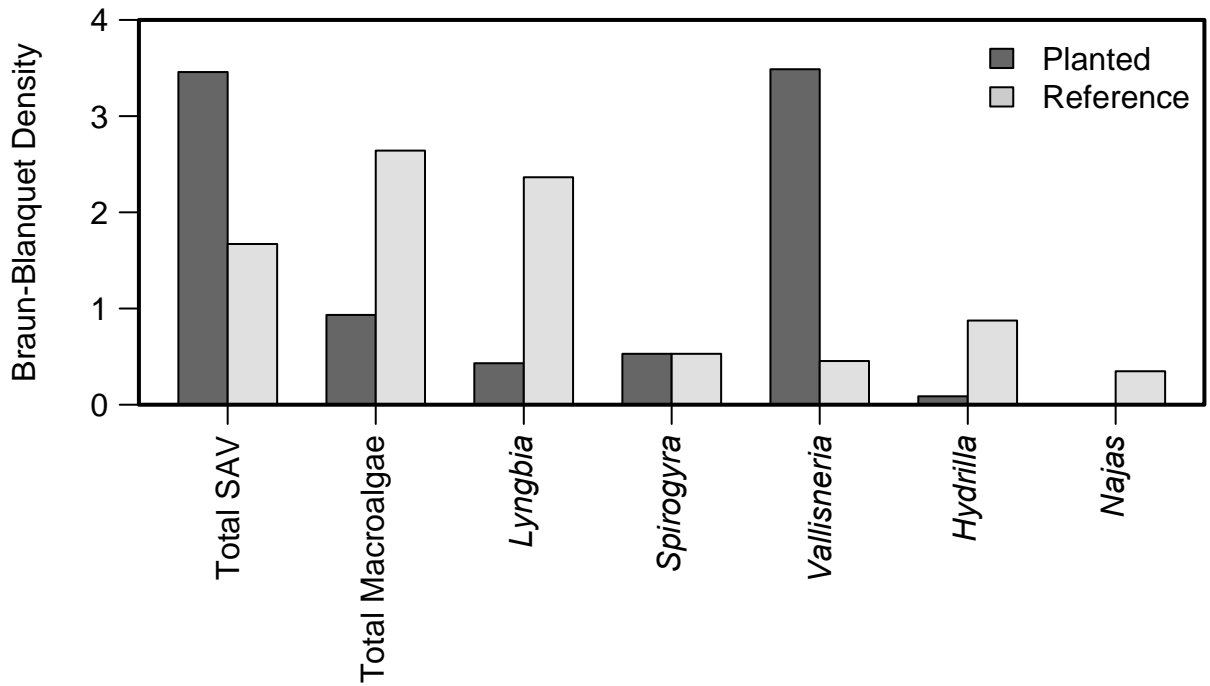
During Campaign 1, Braun-Blanquet densities for total SAV were 2.07 times higher within the planted cages (3.46) than in adjacent reference stations (1.67; Figure 8). This was driven almost entirely by *V. americana* (3.49) that was nearly absent from the reference (0.45). As with other Braun-Blanquet derived metrics, total macroalgal densities were much higher outside of the planted cages than within (2.64 and 0.93, respectively), with *Lyngbia* driving much of that pattern (2.36, reference; 0.43 planted).

Figure 8. Braun-Blanquet densities for SAV and algal species at the planted and reference sites

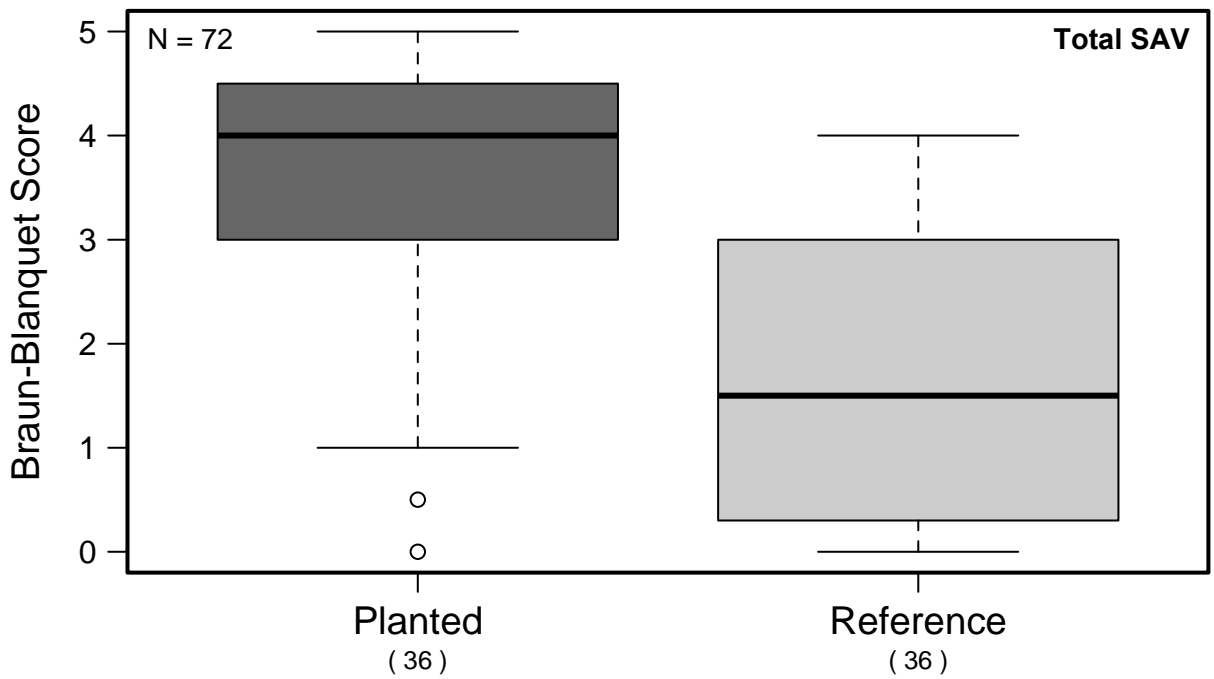
The coverage of total SAV in the relocation sites ranged from 0 to 5 with a mean Braun-Blanquet score of 3.46 \pm 1.33 (Figure 9). This was much higher than in reference locations, which ranged from 0 to only 4 with a mean coverage of 1.67 \pm 1.42.

Figure 9. Boxplot of Braun-Blanquet scores for Total SAV recorded in the planted cages and reference areas during Campaign 1.

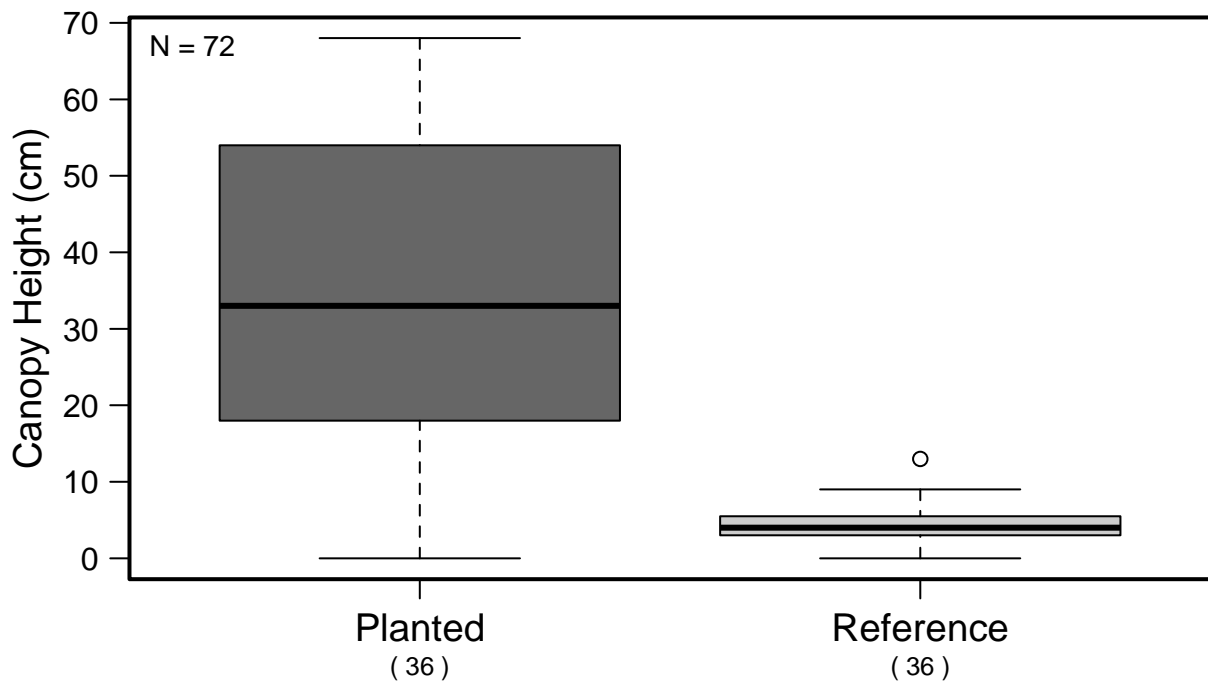
Canopy heights ranged from 0 to 68 cm within GrowSAV cages and 0 to only 13 cm in adjacent references (Figure 10). Mean values were 35.4 \pm 20.4 and 4.4 \pm 2.9 cm, respectively. The disparity was due to the much larger leaf lengths of *V. americana* relative to other SAV and macroalgal components of the benthic plant community. However, this only applied to protected *V. americana*, because reference locations that contain *V. americana* were only marginally taller at 4.75 \pm 2.81 cm relative to 4.25 \pm 2.93 cm for quadrats that did not. This indicates that grazing maintains shorter canopy heights in the absence of cage protection.

Figure 10. Canopy height (cm) for benthic plant communities at the relocation and reference sites.

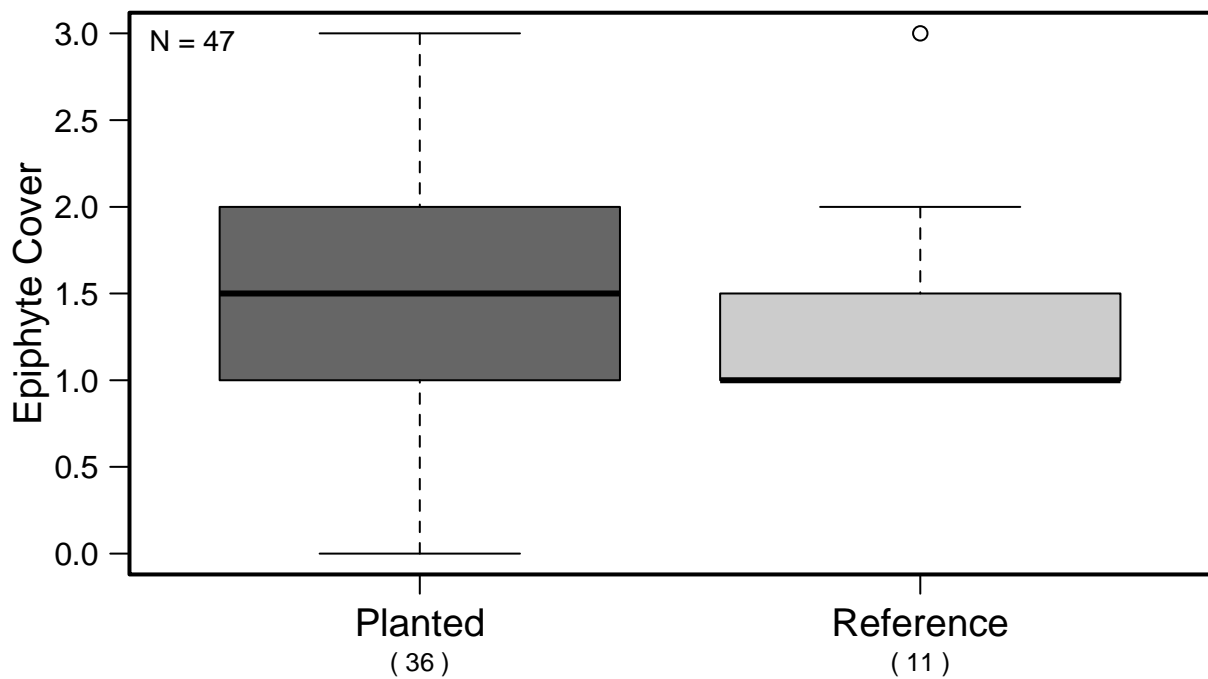
Epiphyte cover was indistinguishable between the planted cages and adjacent controls with mean values of 1.69 \pm 0.91 and 1.86 \pm 0.67, respectively (Figure 11). Based on the epiphyte scale values (Table 3) both treatments had clean to heavy coverage with mean values approximating light epiphytic loading. This is consistent with idea that the primary epiphyte grazers (most likely small invertebrates) were smaller than the GrowSAV mesh aperture, leading to equivalent grazing pressures between treatments.

Figure 11. Epiphytic cover on *Vallisneria americana* at the relocation and reference sites.
