ANNUAL MONITORING REPORT (2 OF 3)

2017

SAVE CRYSTAL RIVER PILOT PLANTING
REPORT

FDEP PERMIT NUMBER: 09-0332123-001
ACOE PERMIT NUMBER: 2015-00363

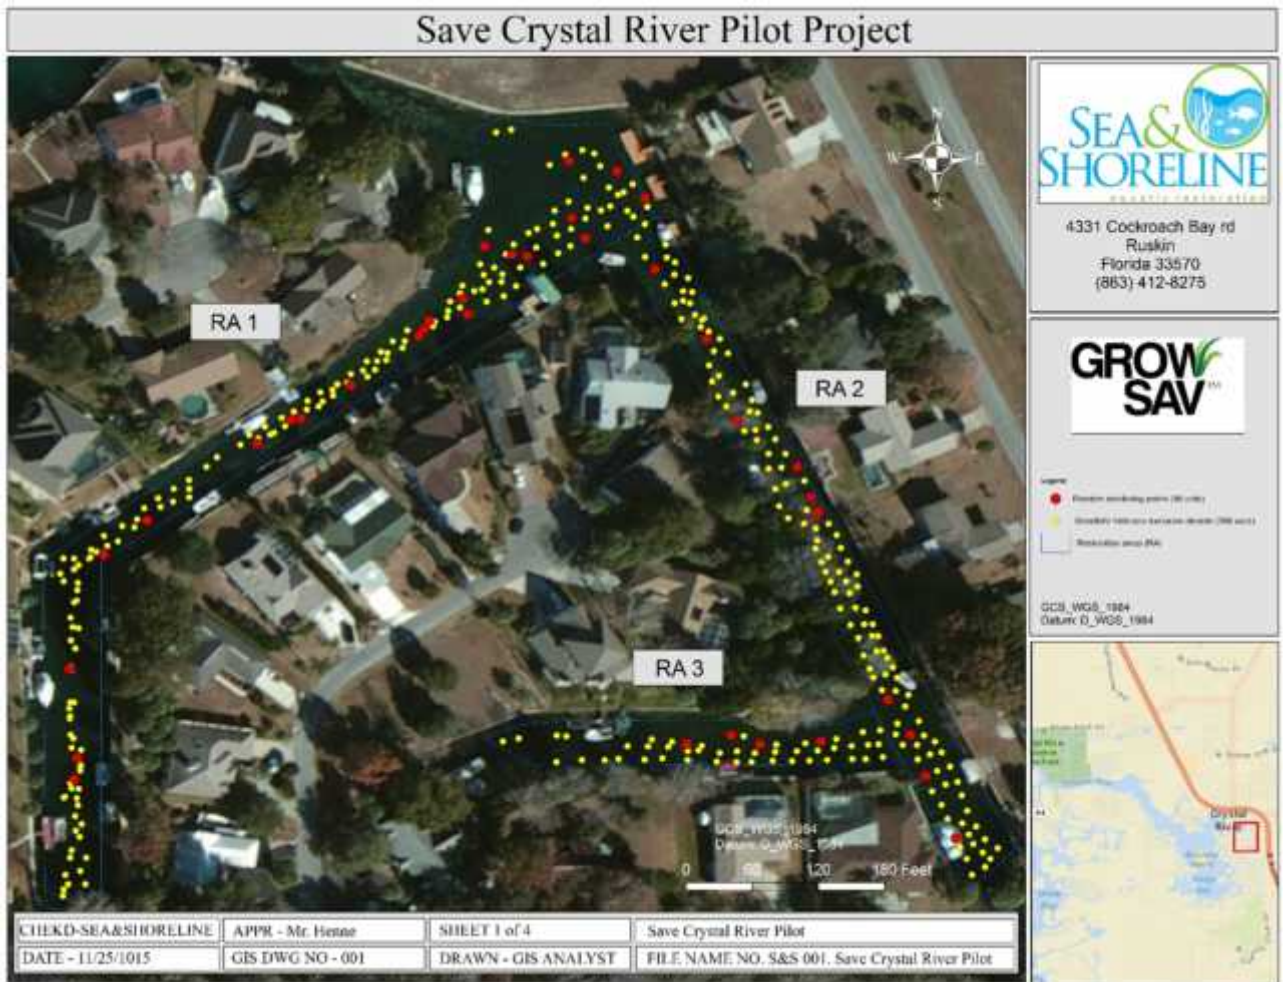
Figure 1. Map showing the location of the grass relocation site (blue polygons), exclusion cages and planting units location (Yellow dots), locations of the permanent sampling sites (red dots).

The transplanting site is situated in the upland canal systems located in the Kings Bay basin. Accessibility to the site was made available by the presence of canals (Figure 1). Sediment inspection revealed that it was muddy-sand to sandy-mud, reflecting the protected nature of the canal system (i.e., reduced fetch). Central water depths were 0.8-2.5 m. Additionally, prior to planting, there was no tape grass or other beneficial submerged aquatic vegetation observed in the restoration area, only filamentous green algae. However, limited populations of *V. Americana* were recorded in adjacent canals.

The transplanting/restoration sites (1, 2 and 3) were nearly rectangular polygons, oriented parallel to the canals (Figure 1). Cages were spaced approximately 3.0 m apart in rows oriented parallel to the shoreline. Between November 9 and 16, 2015 (7 working days) Sea and Shoreline Team transplanted more than 1,800 PUs, into 360 GrowSAV cages (nominally 5 PUs per cage). Once planting was completed, Sea and Shoreline delineated the perimeter of the transplant area using a handheld DGPS unit with sub-meter accuracy (Trimble GeoExplorer 6000). Each cage was physically tagged for future identification, and 10% of the 360 units were haphazardly selected for monitoring. As a reference, randomly located positions were selected no less than 2 m from each monitoring point. All monitoring and reference locations were permanently tagged. A small waterproof label was securely attached to the looped end onto the cage. Planting and reference points (72 total points) were monitored during each sampling campaign. WGS coordinates of the 36 sampling points are presented in Table 1 while that of the 36 reference points are presented in Table 2.

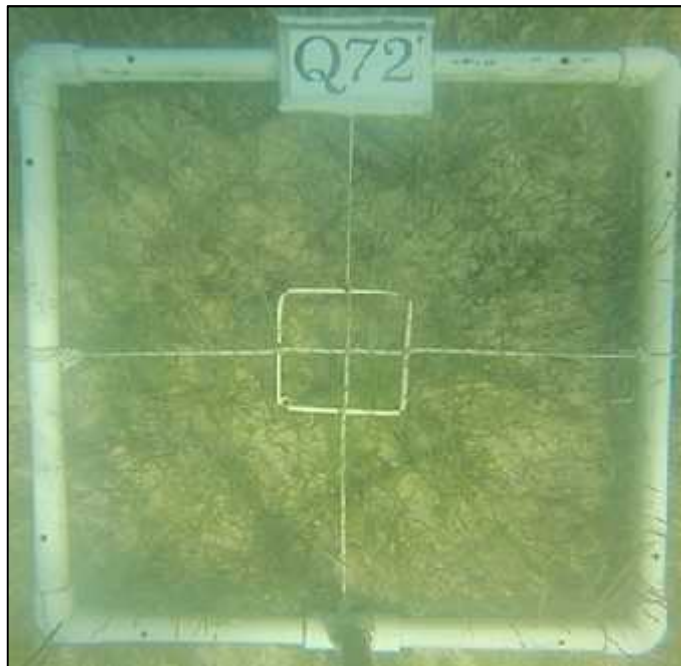
Figure 2. Underwater photograph showing the shoot count quadrat (10 cm x 10 cm) placed inside the center of the larger Braun-Blanquet quadrat (100 cm x 100 cm, not to scale).

V. Americana shoot density was estimated at each of the 72 individual permanent sampling points by placing a 10 x 10 cm quadrat in the center of each Braun-Blanquet monitoring quadrat and manually counting all of the shoots present (Figure 2). Shoot count data was then multiplied by 100 to obtain shoot densities in the number of shoots per square meter (shoots/m²). Total grass shoot density is reported the sum of all species counted in a quadrat (shoots/m²). The data are reported as mean densities per treatment: planted (N =36) and reference (N = 36).

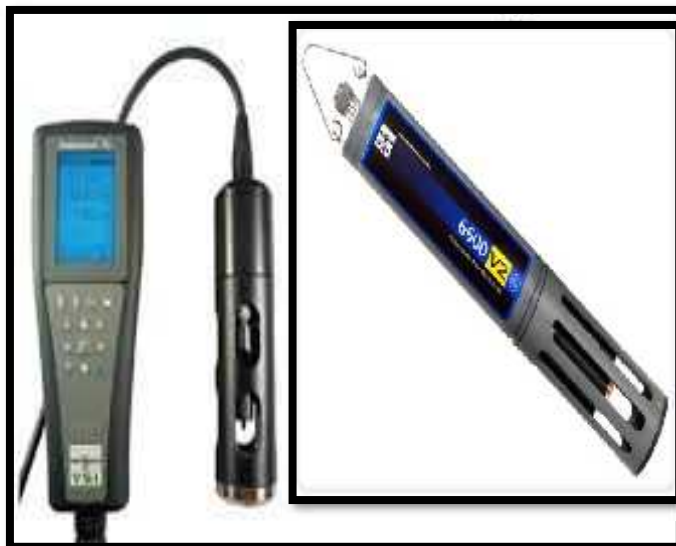
Figure 3. YSI Professional Plus multi-parameter water quality logger. Inset – YSI 6600 V2 Sonde

Water temperature, pH, salinity, dissolved oxygen (DO) and turbidity (NTU) were measured at the surface and bottom at four (4) stations once during each monitoring event (two stations per treatment) using a calibrated YSI 6600 V2 sonde or a YSI Professional Plus multi-parameter water quality logger (Figure 3). The water quality values for each individual parameter at each depth are reported as mean values for the two stations at the planted and reference sites, respectively. Water quality measurements were further evaluated for compliance with DEP/EPA Standards for environmental protection.
