**CORE SAMPLING  
BENTHIC ASSESSMENT OF CANALS 5 and 7  
IN KING'S BAY**

**December 5, 2018**

*Interim Report Prepared for:*

**Save Crystal River, Inc.  
Post Office Box 2020  
Crystal River, Florida 34423  
&  
DEP Agreement LP09112**

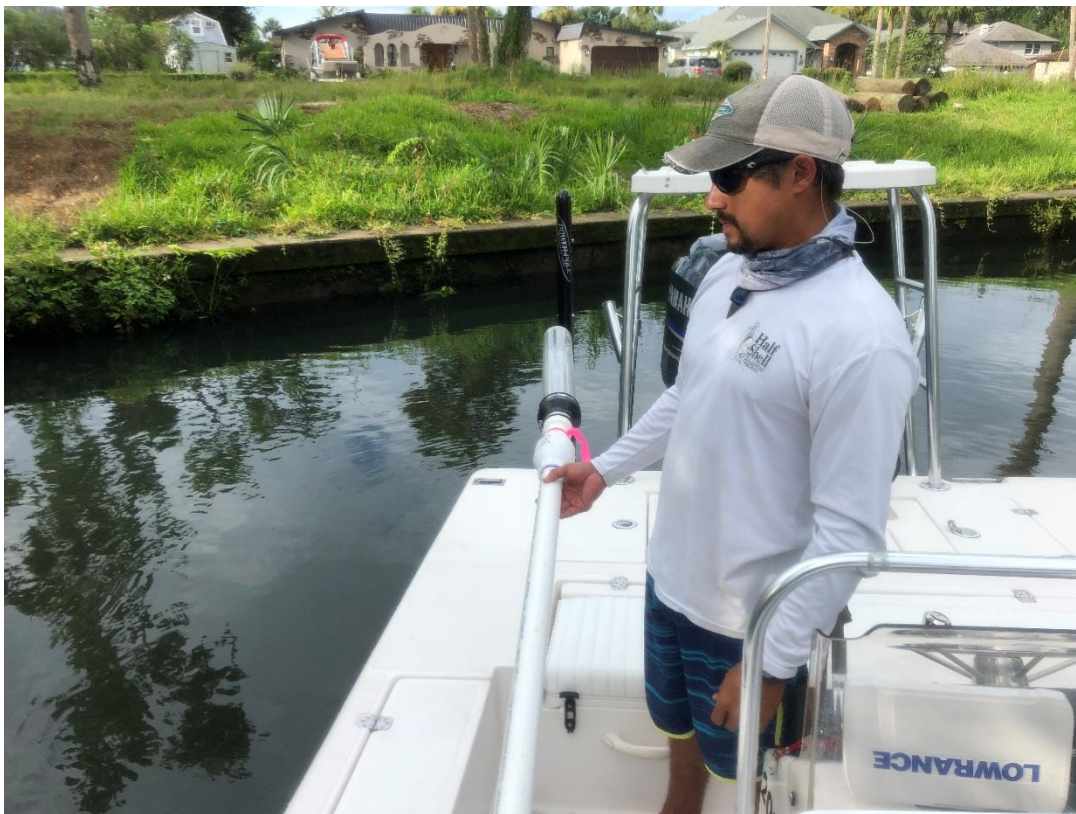
Figure 1. Core sampling device ready to be deployed in Canal 3, August 13, 2018.

Core samples from the benthos were collected using a customized vacuum core sampler developed by Florida Gulf Coast University for limnological studies and characterizing sediment types. The core sampler consists of a 3.1 meter-long section of 3.8 cm diameter schedule 40 PVC pipe, with a one-way ball valve, rubber coupler, and 7.6 diameter x 0.75 meter clear Plexiglas™ cylinder at the base for collecting and viewing benthic samples (Figure 2).
