BASELINE BENTHIC SAMPLING & REPORT KING'S BAY RESTORATION AREA: PHASE 3B-3

April 26, 2022

This report summarizes the results of **Task 2a. Core Samples and Report**: The contractor will collect ten (10) core samples at stratified random locations to represent baseline sediment profiles in Phase 3B3 of The Kings Bay Restoration Project (Figure 1). Sediment profiles will be photographed, analyzed, and recorded for future comparison with post-restoration core samples. This report includes the results of pre-restoration (baseline) to document conditions before de-mucking of Phase 3B3.

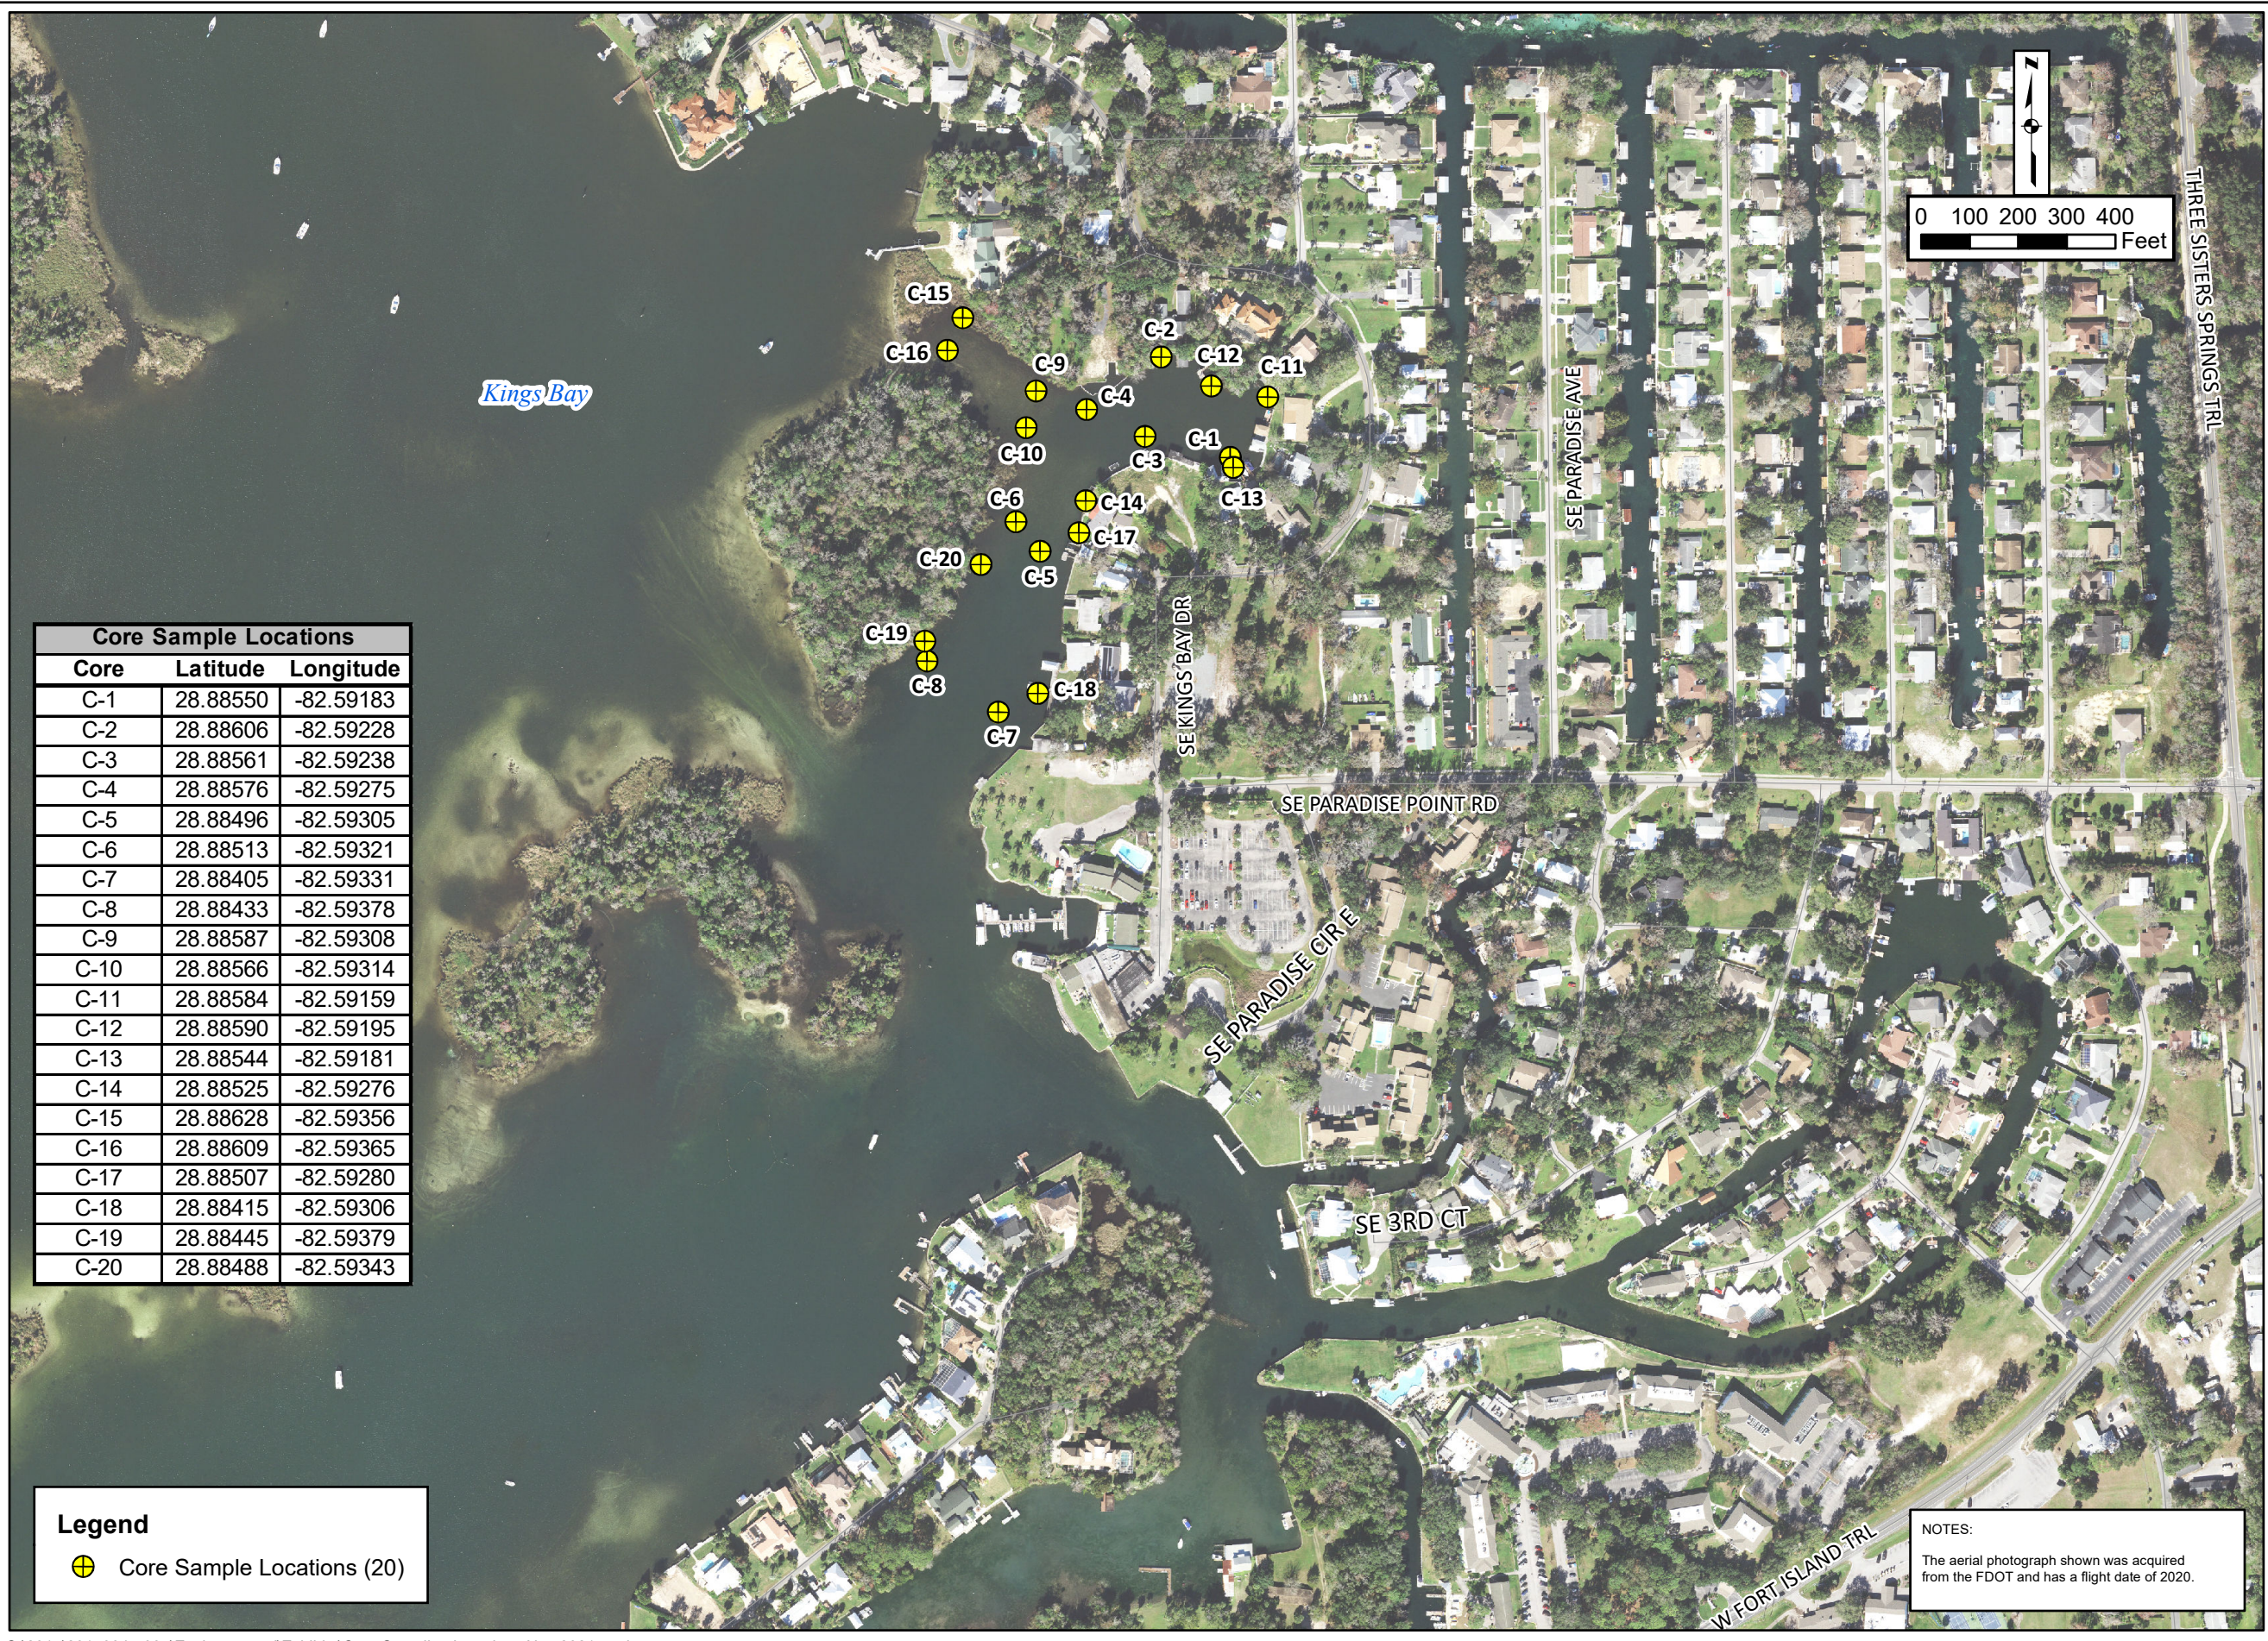
Fig. 2

Core Sampling
 Locations

Core Sample Locations		
Core	Latitude	Longitude
C-1	28.88550	-82.59183
C-2	28.88606	-82.59228
C-3	28.88561	-82.59238
C-4	28.88576	-82.59275
C-5	28.88496	-82.59305
C-6	28.88513	-82.59321
C-7	28.88405	-82.59331
C-8	28.88433	-82.59378
C-9	28.88587	-82.59308
C-10	28.88566	-82.59314
C-11	28.88584	-82.59159
C-12	28.88590	-82.59195
C-13	28.88544	-82.59181
C-14	28.88525	-82.59276
C-15	28.88628	-82.59356
C-16	28.88609	-82.59365
C-17	28.88507	-82.59280
C-18	28.88415	-82.59306
C-19	28.88445	-82.59379
C-20	28.88488	-82.59343

To determine that *Lyngbya (Microseira wollei)* and flocculent organic substrate has been sufficiently removed to sustain *Vallisneria americana* restoration, colonization, and survival; a total of 10 benthic core samples were collected on October 12, 2021. Based on the highly variable results obtained from the initial ten (10) core samples, an additional ten (10) benthic core samples (total of 20 cores) were collected on November 2, 2021, to obtain a more complete representation of the baseline sediment conditions. Figure 2 shows the location of all 20 core samples collected during the baseline sampling event.

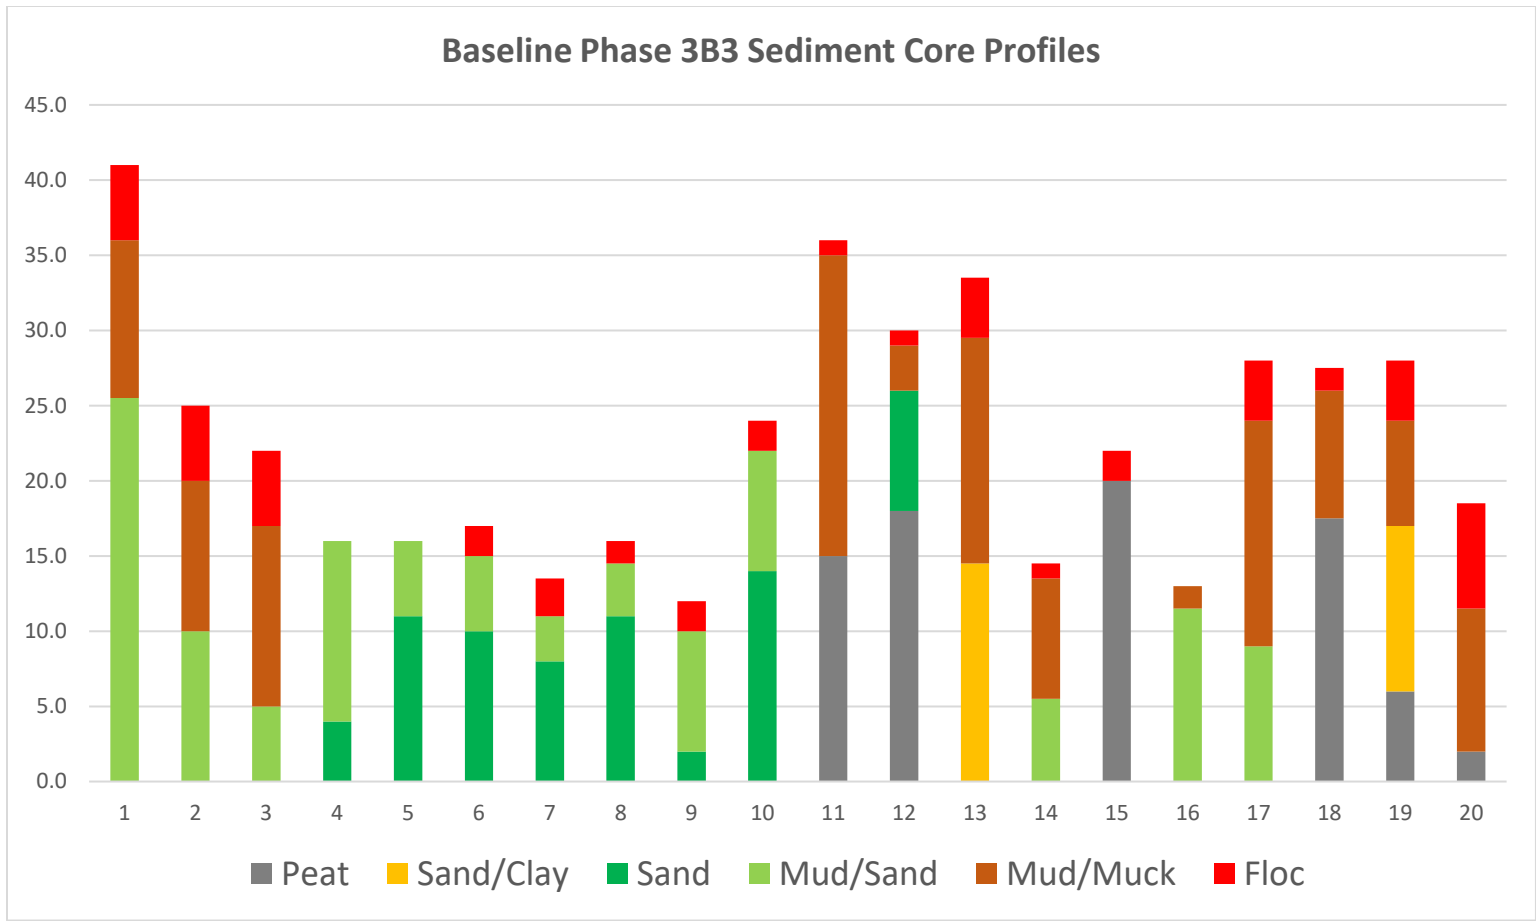
Figure 3. Kings Bay Restoration Phase 3B3: Baseline sediment core profiles collected October 12 (Core 1-10) and November 2 (Cores 11-20), 2021 by Johnson Engineering, Inc. Depth in centimeters (cm) of each constituent on the Y axis and core sample number (1-20) on the X axis.

The initial ten (10) core samples collected from Phase 3B3 showed highly variable sediment profiles with flocculent organic layers ranging from 0.0 cm up to 5.0 cm with underlying mud/muck layers from 0.0 up to 12.0 cm deep (Table 1, Figure 3). Total core depths were dependent on softness of the sediments and ability to penetrate with the PVC core device. Total core depths for the first ten samples ranged from 12.0 to 41.0 cm, with the deepest cores collected from areas with deep mud/muck layers. To obtain better spatial resolution, an additional ten (10) core samples were collected and analyzed from stratified locations to fill in gaps. Generally, areas with higher current velocities and regular tidal flushing contained little if any floc, and less mud/muck (C-4 through C-10) while areas with less tidal flushing contained deep layers of floc and mud/muck (Figure 2 and Table 1). A total of six (6) of the 20 core samples were collected from areas that contained some *Vallisneria americana* growing on top of the sediment (Table 1). Drone photos were collected during the second core sampling event on November 2, 2021, to estimate baseline SAV cover. Of the total area of 7.67-acres in Phase 3B3, approximately 30% (2.3-acres) was mapped as SAV cover. Deep peat deposits were identified at four locations, C-11, C-12, C-15 (Figure 4), and C-18, while deep clay layers were found at C-13 and C-19 (Table 1, Figure 3). These highly variable sediment profiles indicate dynamic flow conditions and erosional forces exist that appear to redistribute fine organics to areas of low velocity along the east side of the island, some shallow flats, and the northeastern terminus of Phase 3B3.

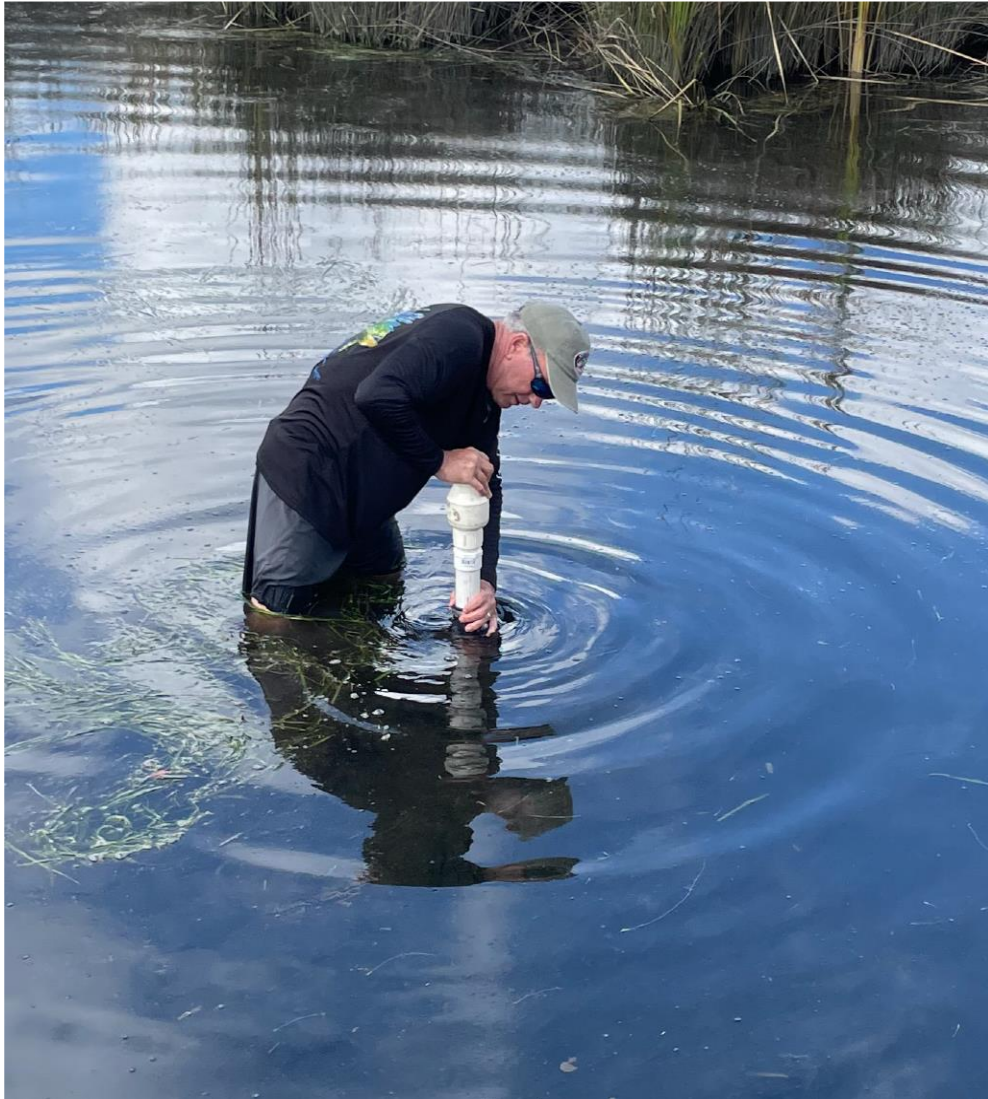
Figure 4. Senior ecologist and project manager (D.W. Ceilley) using core sampling device in shallow waters at Phase 3B3 to collect Core #15 on November 2, 2021.

The core sampler consists of a 3.8 cm diameter x 3.1-meter-long section of schedule 40 PVC, with a one-way ball valve, rubber coupler, and 7.6 cm diameter x 0.75-meter-long clear Plexiglas™ cylinder at the base for collecting and viewing samples (Figure 4, Attachment A). Upon collection cores were removed from the PVC extension and photographed against a white board with location and date for archival and later comparison with post-restoration sediment profiles.
