# **BENTHIC SEDIMENT SAMPLING REPORT KING'S BAY RESTORATION AREAS**

**February 27, 2025**

**Save Crystal River, Inc.  
915 N. Suncoast Blvd.  
Crystal River, Florida 34429**

**D.W. Ceilley, M.S., CSE**

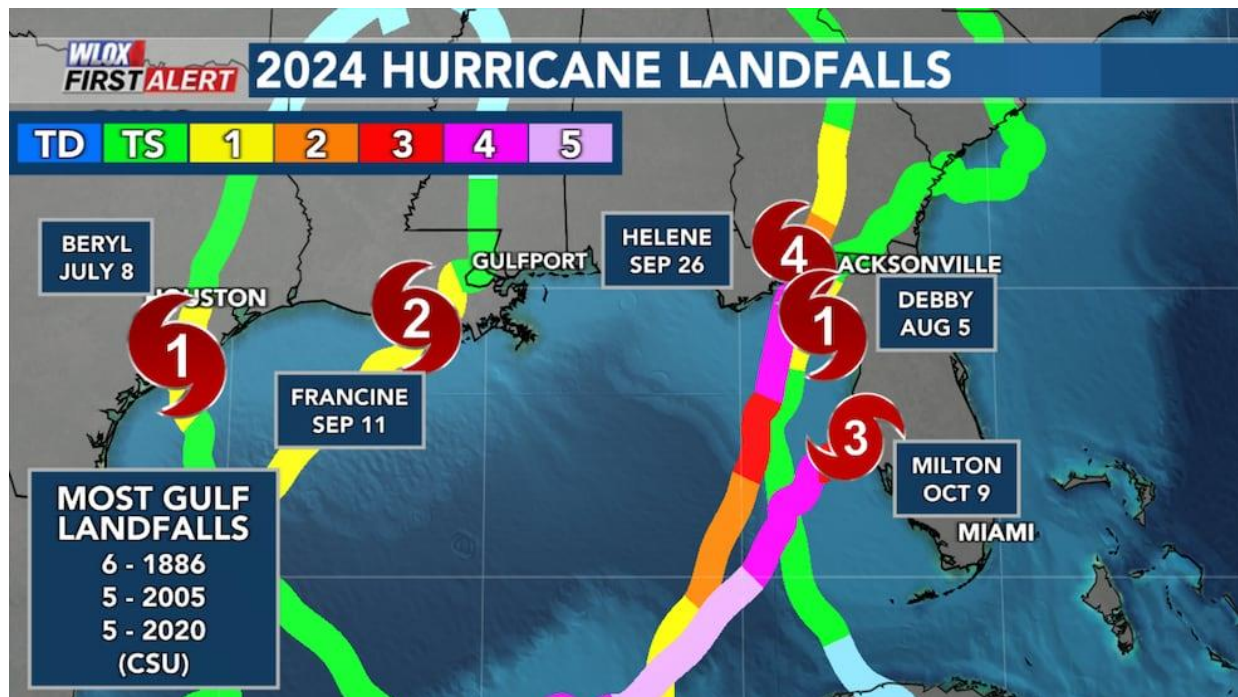
**Figure 4.** Hurricane tracks for all five hurricanes that made landfall in the Gulf of Mexico in 2024.

**Figure 4.** shows the paths, strength categories, and landfall dates of five hurricanes that made landfall in the United States in 2024. Prior to that, hurricane Idalia made landfall as a Category 3 storm on August 30, 2023. Kings Bay was inundated with a storm surge between 9 to 12 feet resulting in severe coastal flooding in Crystal River, Florida (**Figure 5**). The impacts of Idalia’s saltwater storm surge on *Vallisneria* were still being assessed by Sea and Shoreline biologists when the hurricane season of 2024 produced Hurricanes Debby, Helene, and Milton that also impacted Kings Bay.

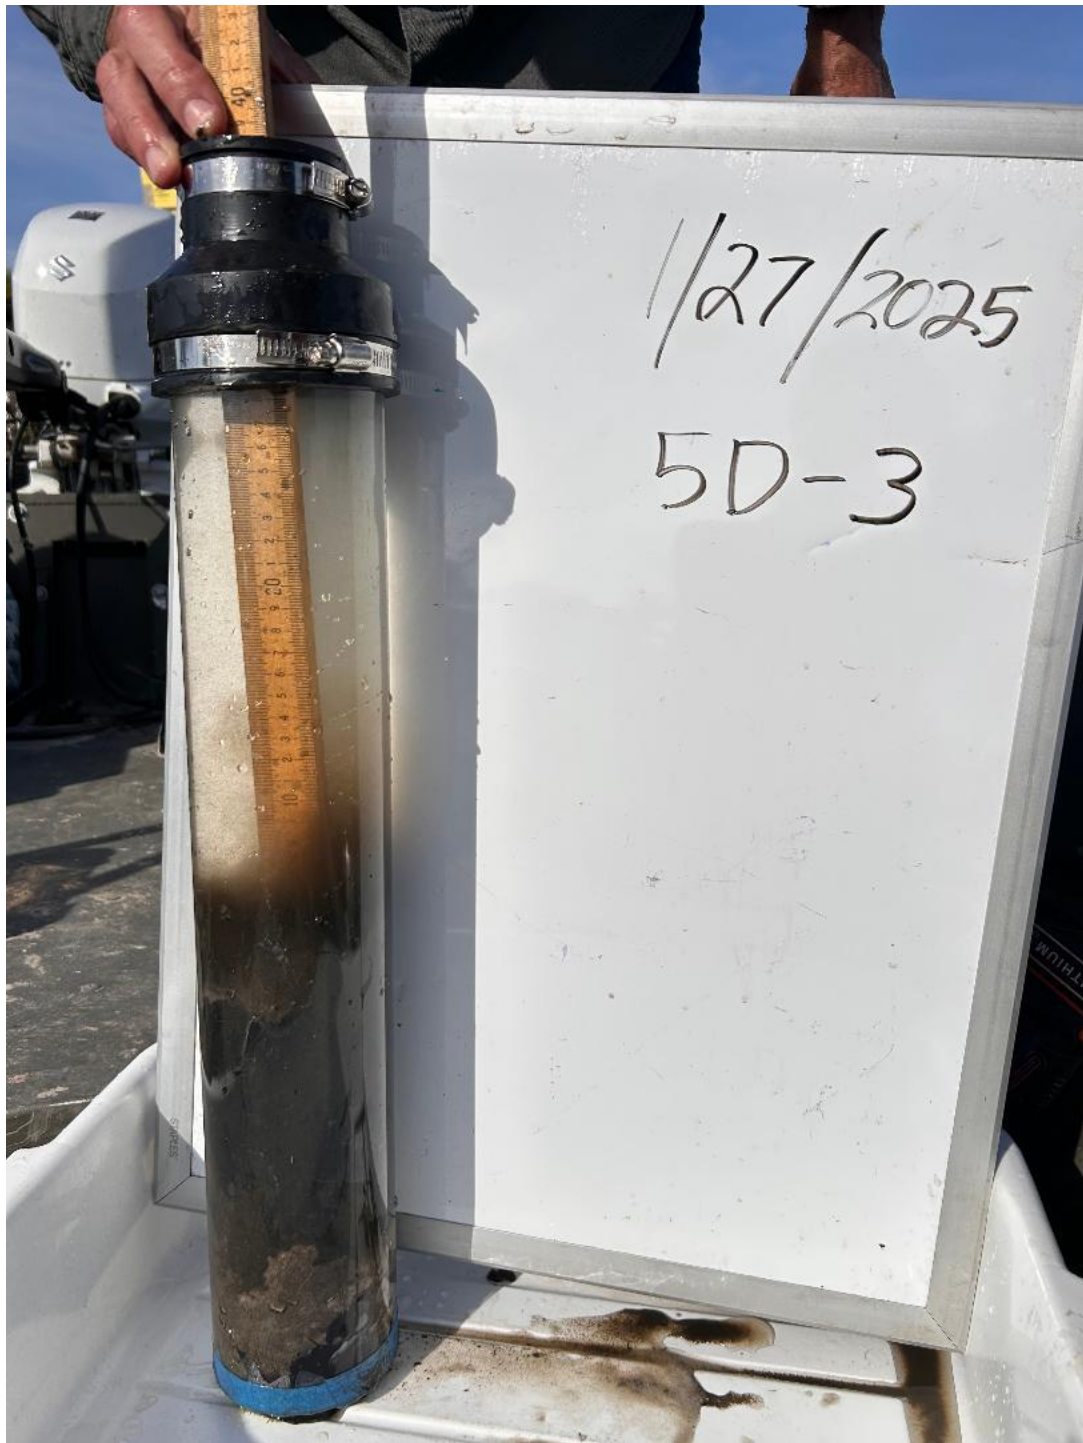
Area 5D had the deepest layers of floc, ranging from 7.0 to 10.0 cm with a mean depth of 8.0 cm and the deepest deposits of mud/muck with a range from 10.0 to 15.0 cm and an average depth of 13.0 cm. The upper layers were consistent in Area 5D, with thick mud/muck topped with 7-10 cm of flocculent organic matter. Samples from the 5D area may represent sloughing of material from adjacent shallows outside of the de-mucking footprint because of hurricanes wind driven currents and storm surge(s).

**Kings Bay sediment core sample collected from Phase 5D-1.**

**Kings Bay sediment core sample collected from Phase 5D-3.**

**Kings Bay sediment core sample collected from Phase 5D-5.**

- Phase 5D sites had deep deposits of floc and soft mud/muck that are unsuitable for long-term survival of native SAV. The floc and mud/muck layers in 5D may have been deposited from adjacent open water habitats of Kings Bay that were not de-mucked. Other sites in Phase 5 that contained excessive floc were 5A4, 5B1, 5C1, 5C3, and 5C6.

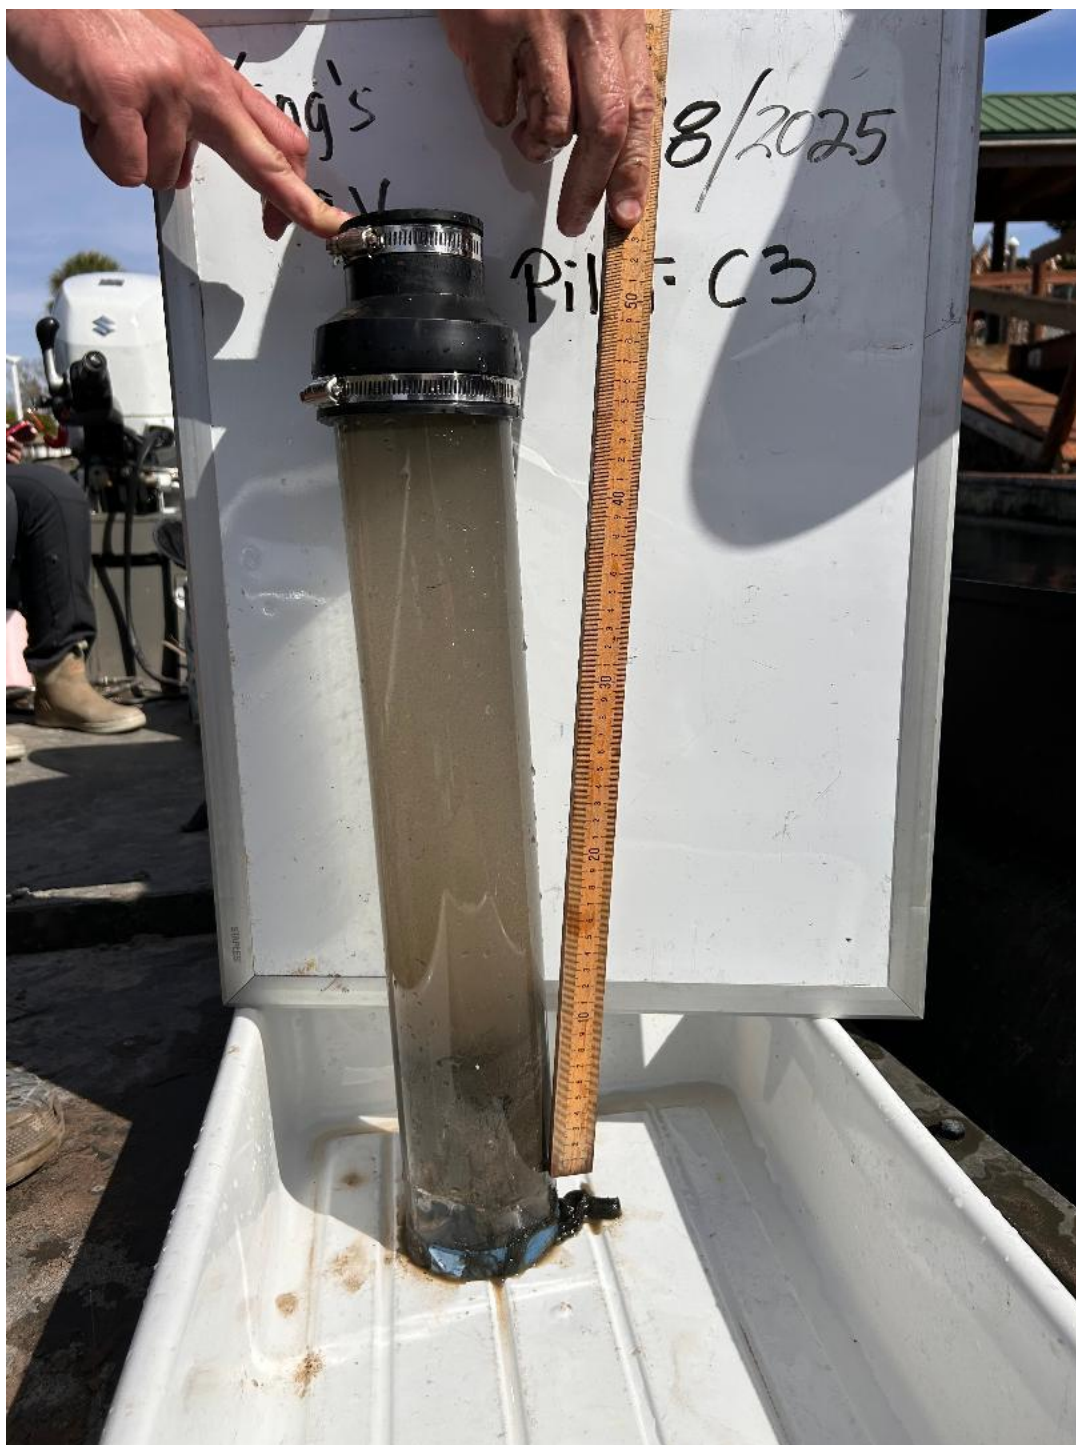
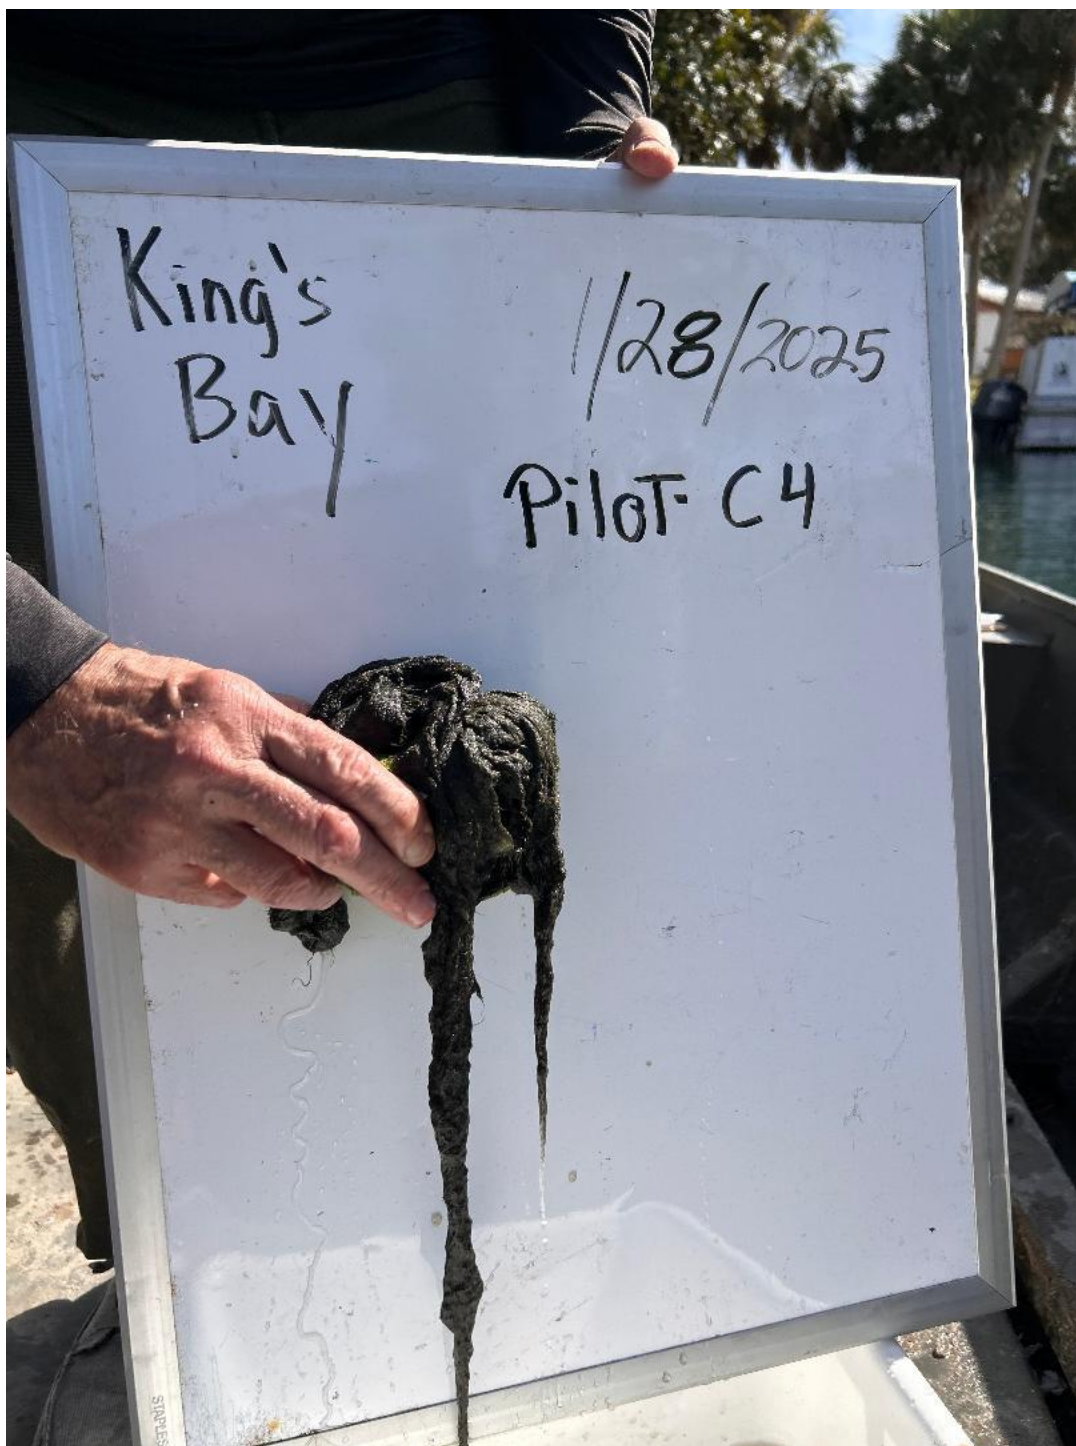
The Pilot project restoration area consists of dead-end canal habitats that were de-mucked in 2017. Two samples collected at Pilot 1 and Pilot 2 (**Figure 2**) contained deposits of mud/muck of 10.5 and 11.5 cm respectively (**Table 2, Figure 9**). Both samples contained a floc layer and a layer of the filamentous blue-green algae or cyanobacteria, *Lyngbya wollei*. Pilot 3 contained a similar profile with shallower layers of each constituent. Pilot 4 consisted entirely of *Lyngbya* over a hard bottom of rock or gravel that could not be collected by the vacuum core sampler. Samples from Phase 1A also had a layer of *Lyngbya* but underneath was a thick layer of sand that is considered ideal for *Vallisneria* establishment. A biological assessment conducted by Johnson Engineering (2018) documented dense *Vallisneria* beds throughout this area that were lost from the repeated hurricane storm surges in 2023 and 2024 (**Figures 4, 5, 6 and 7**).

**PILOT C1**  
**Kings Bay sediment core sample collected from Pilot Project area.**

**PILOT C2**  
**Kings Bay sediment core sample collected from Pilot Project area.**

**PILOT C3**  
**Kings Bay sediment core sample collected from Pilot Project area.**

**Kings Bay sediment core sample collected from Pilot Project area.**

- The Pilot Project canal contained a nearly contiguous layer of *Lyngbya* on top of the sediments. Cores from Pilot 1, 2, and 3 contained layers of floc and mud/muck layers that may reflect deposition from one or more of the hurricanes that impacted Kings Bay in 2023-24. To ensure the recovery of SAV beds, the Pilot Project area needs de-mucking and removal of the *Lyngbya* layer.
