BENTHIC ASSESSMENT OF CANALS 2S, 3, and 6 PHASE 1 B/C IN KING'S BAY REPORT

February 18, 2019

**Save Crystal River, Inc.
Post Office Box 2020
Crystal River, Florida 34423
FDEP LP09023**

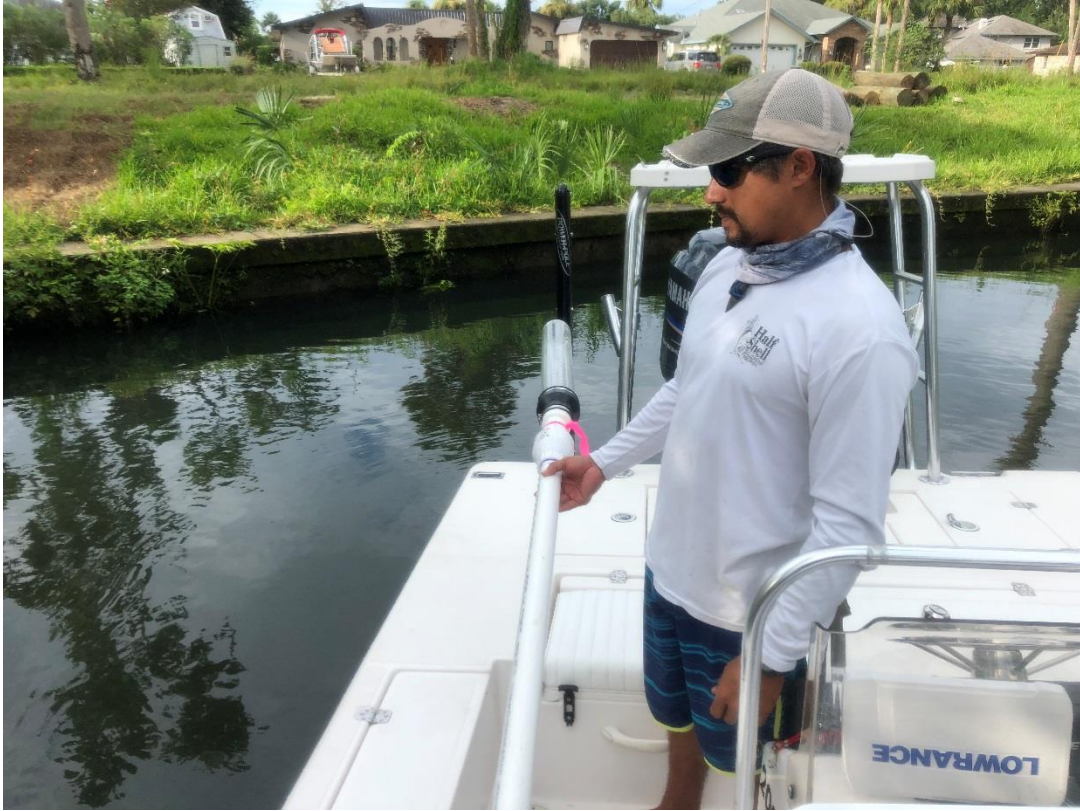
Figure 1. Core sampling device ready to be deployed pre-restoration in Canal 3, August 13, 2018.

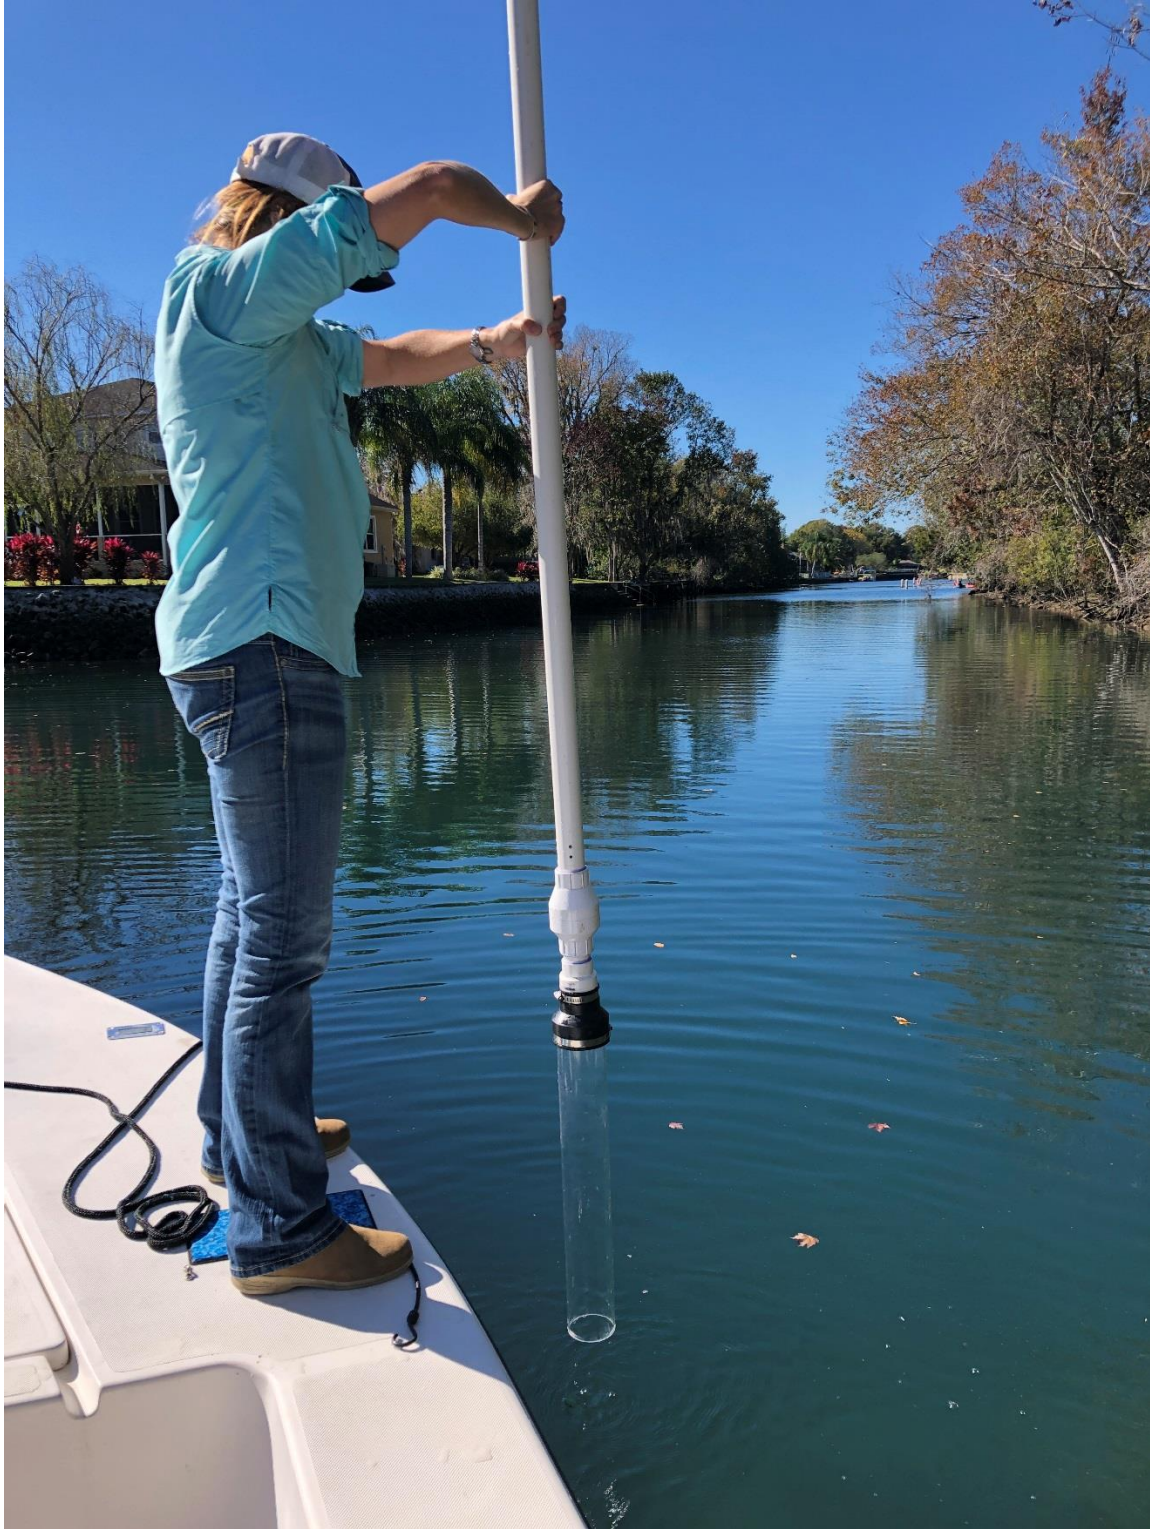
Johnson Engineering ecologist deploying customized core sampler in Canal near Three Sisters Spring, Kings Bay, Citrus County Florida.

The customized core sampler with clear Plexiglas™ cylinder proved to be an effective sampling tool for sampling and identifying soft sediment profiles in each of the three canals surveyed in this project study area. Sediment profiles can be extracted and examined in the field for rapid assessment of benthic habitat conditions pre and post-restoration. This core sampler is not suitable for hard bottom sampling or in areas with gravel, large shell fragments, oysters or dense woody debris.

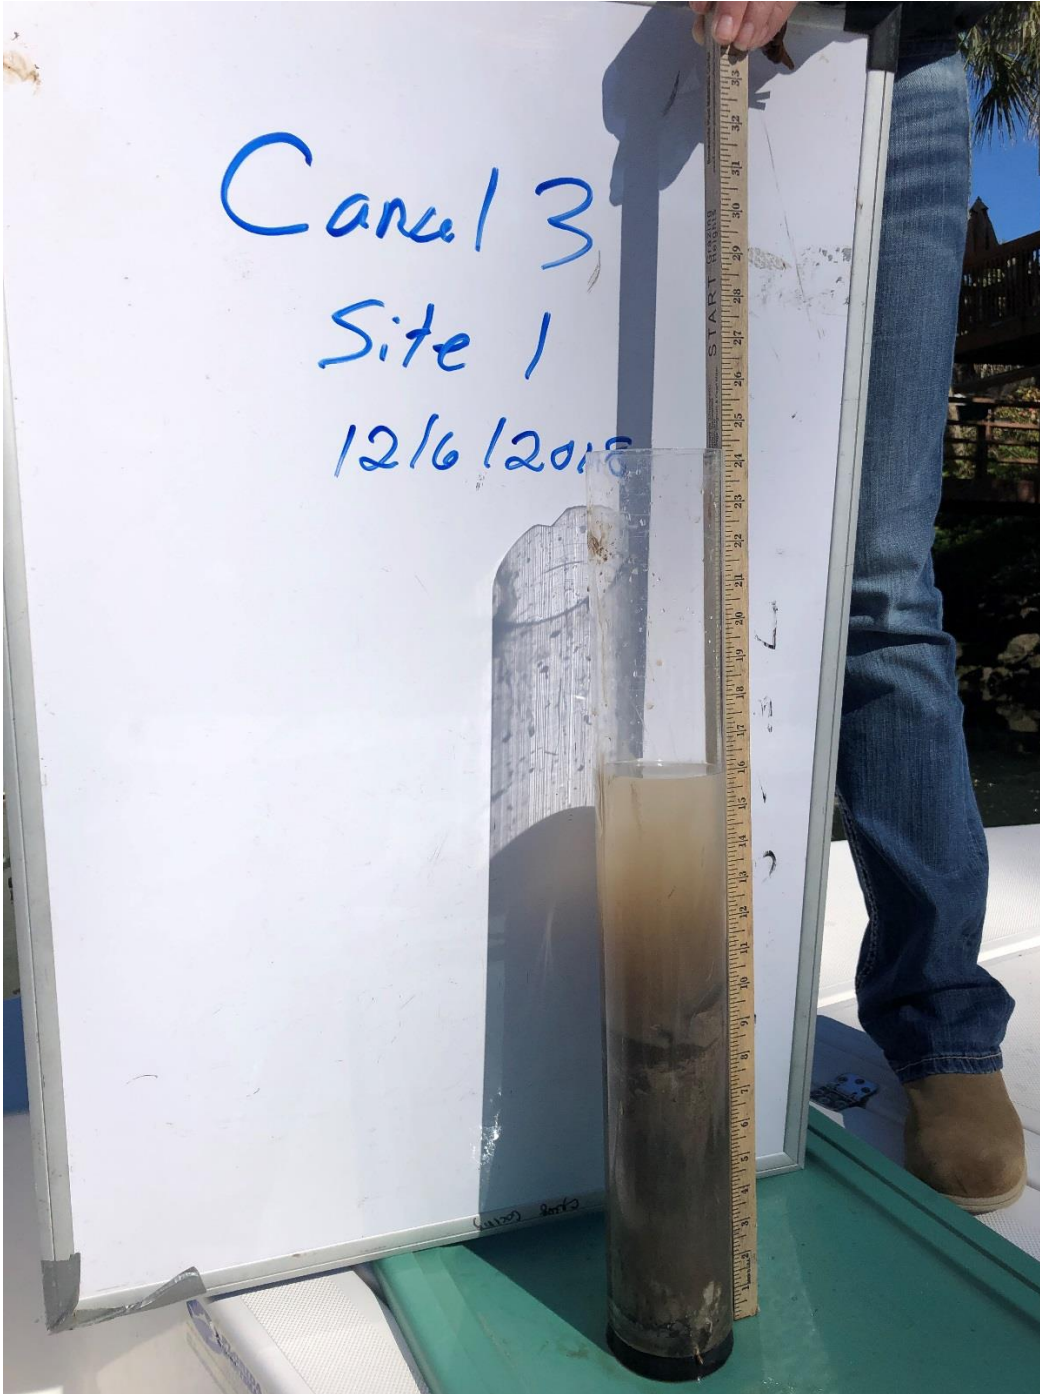
Canal 3; Core Sample 1 near southern terminus of canal with 12.5 cm of mud/sand mix, 11.6 cm clay, 2.5 cm shell layer and 0.1 cm flocculent material (floc/*Lyngbya*).

Note that yardstick is in inches and values were converted to metric for reporting

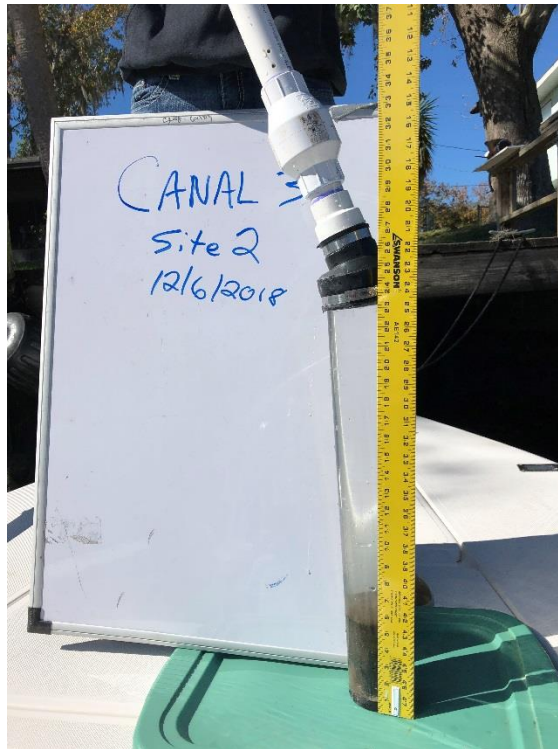
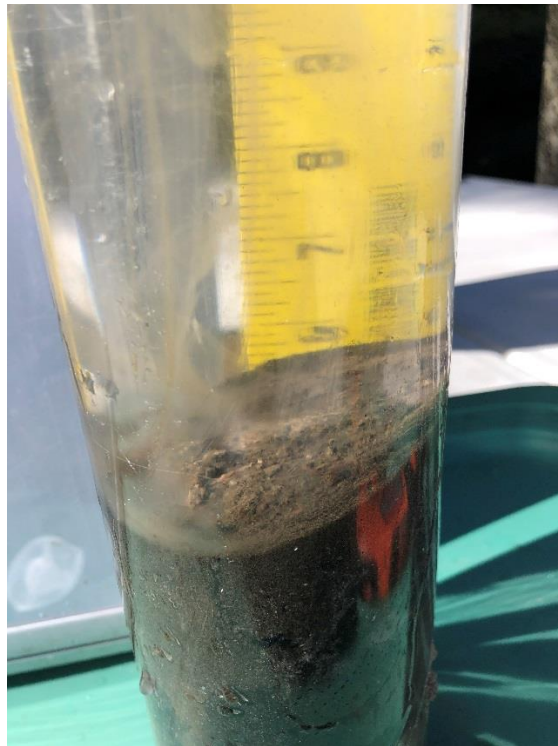
Canal 3; Core Sample 2 with 10.2 cm mud/sand, 2.5 cm clay, and ≤ 0.1 cm floc.

Note that yardstick is in inches and values were converted to metric for reporting

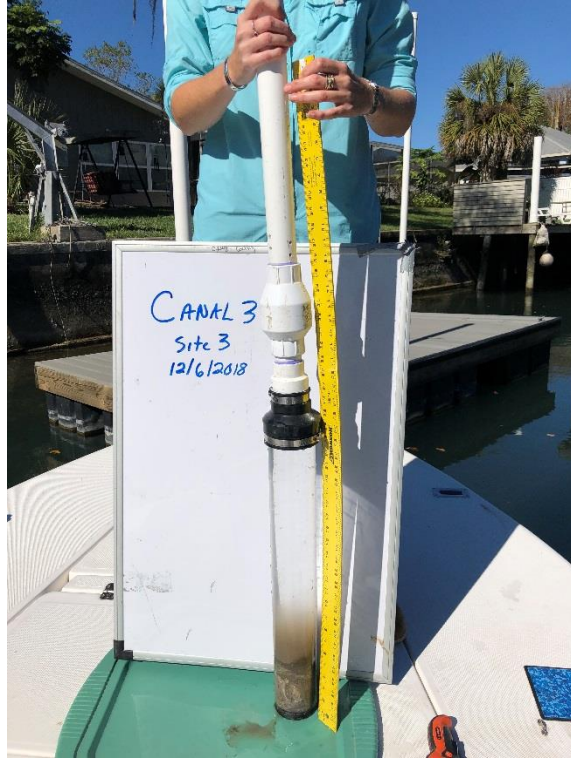
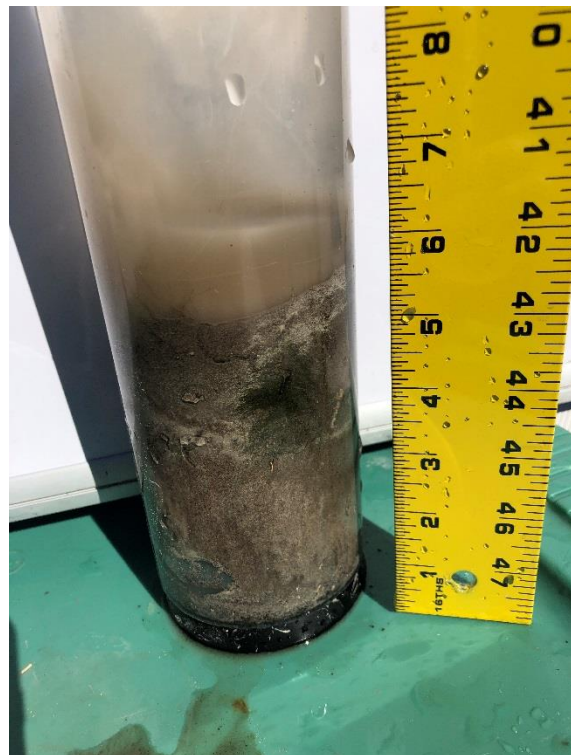
Canal 3; Core Sample 3 with 11.5 cm mud/sand mix with 0.3 cm floc.

Note that yardstick is in inches and values were converted to metric for reporting

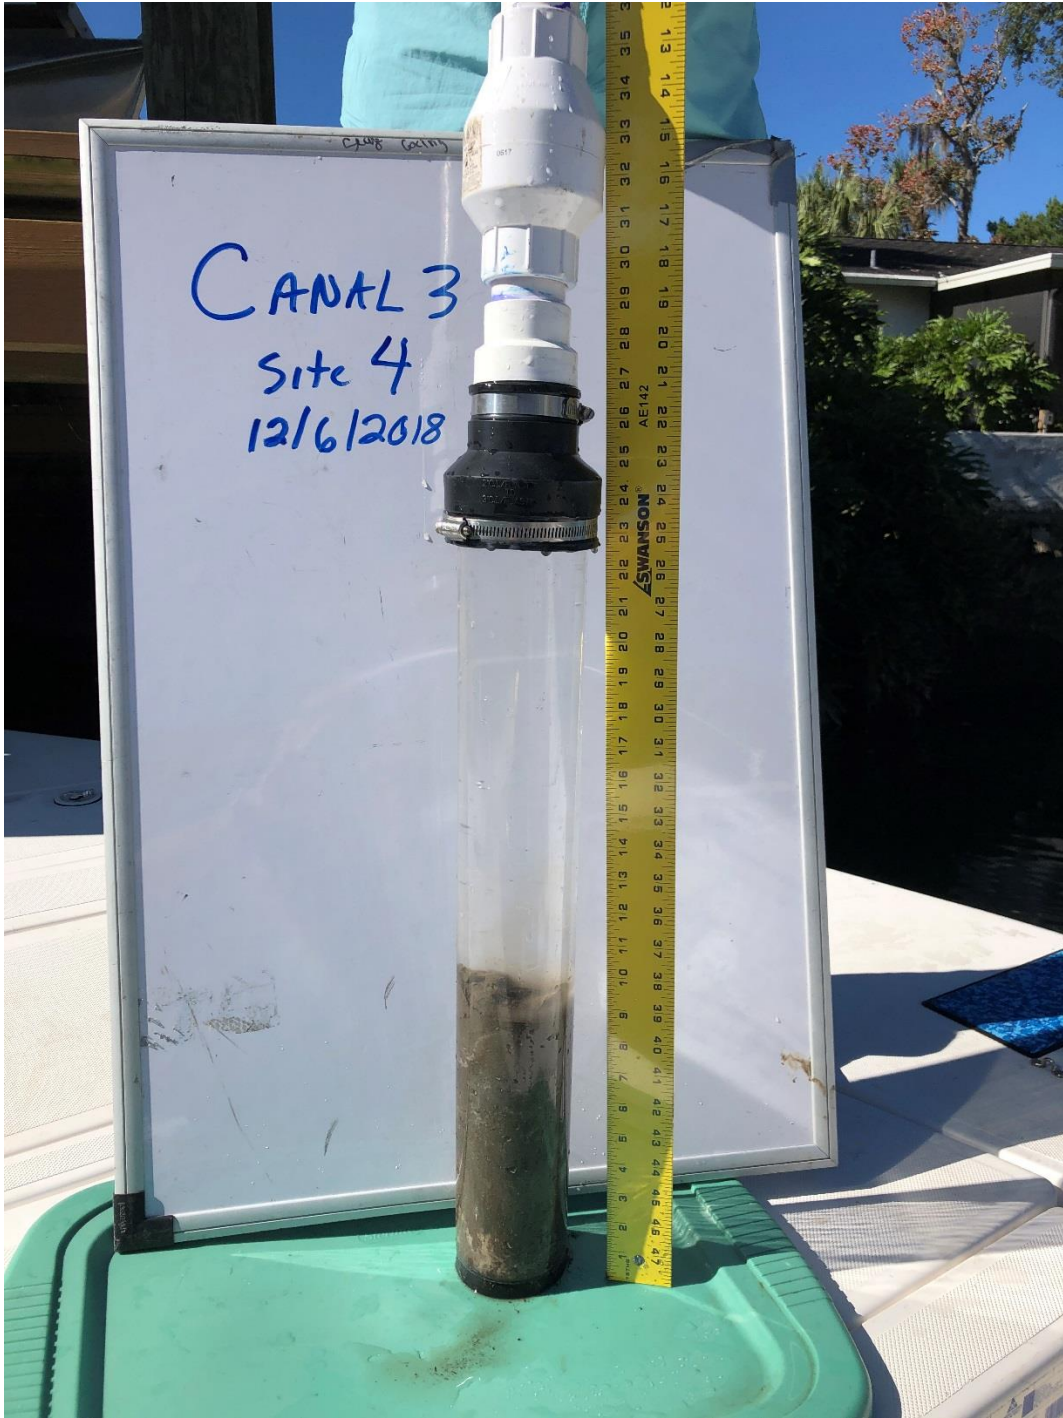
Canal 3; Core Sample 4 with 23.0 cm of mud/sand, 1.2 cm clay, and 0.8 cm floc.

Note that yardstick is in inches and values were converted to metric for reporting

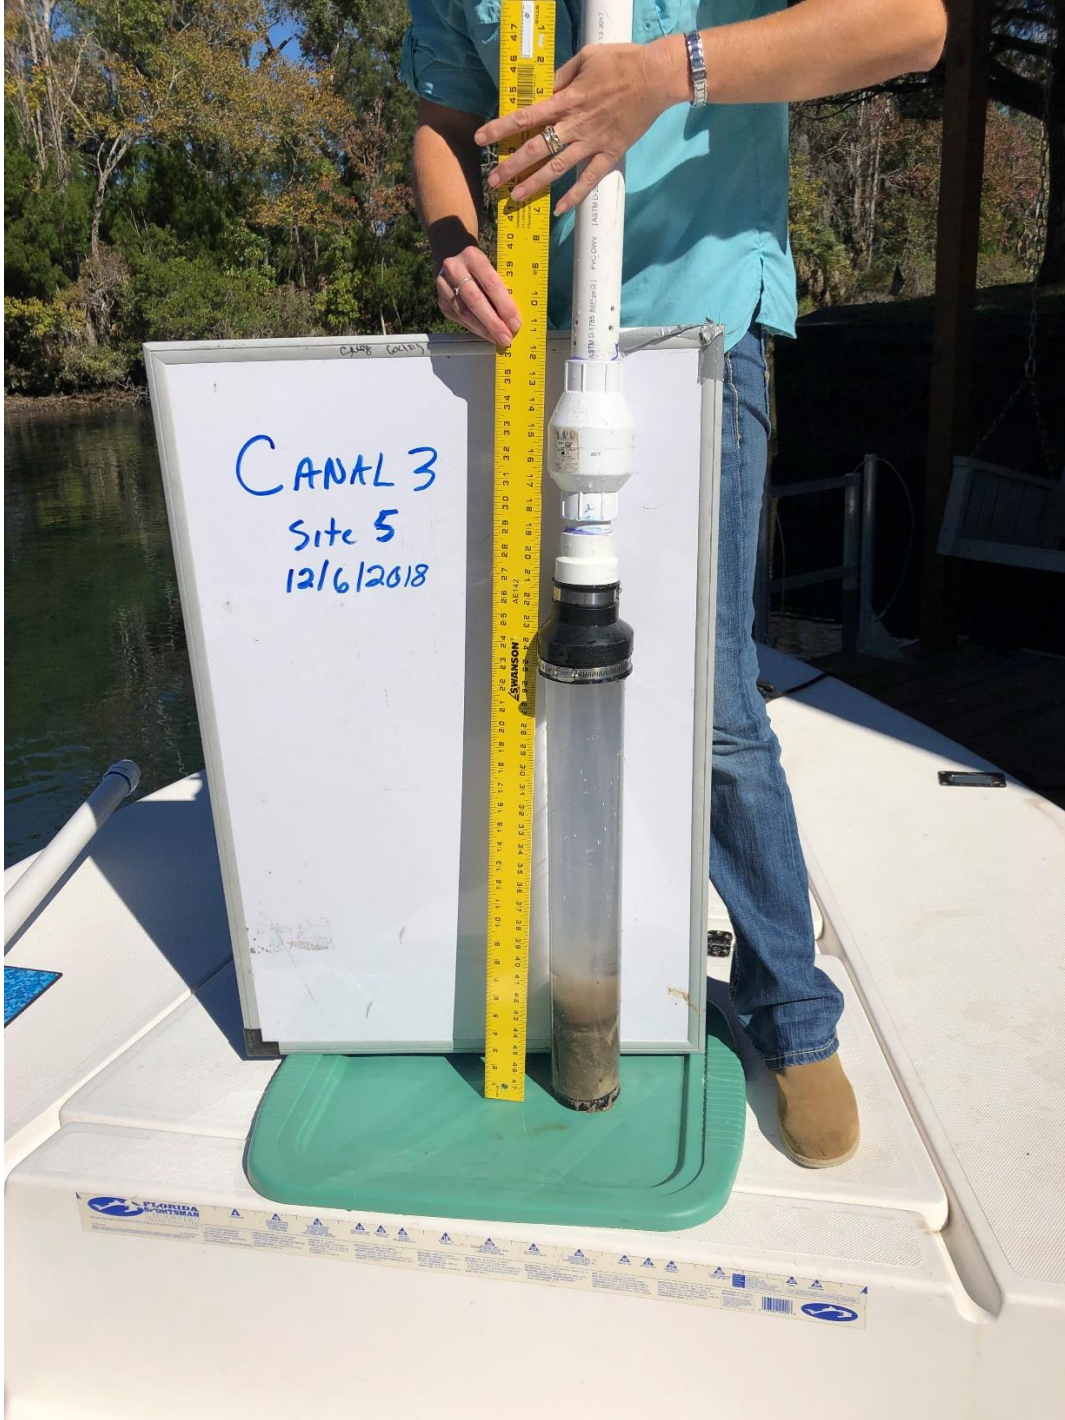
Canal 3; Core Sample 5 with 15.2 cm mud/sand mix and 0.3 cm flocculent material.

Note that yardstick is in inches and values were converted to metric for reporting
