BENTHIC ASSESSMENT OF CANALS IN PHASE 1B

January 15, 2018

JOHNSON
ENGINEERING

Phase 1B: Tape Grass Restoration Benthic Sampling
Johnson Engineering Inc. Ft. Myers, FL
January 15, 2018

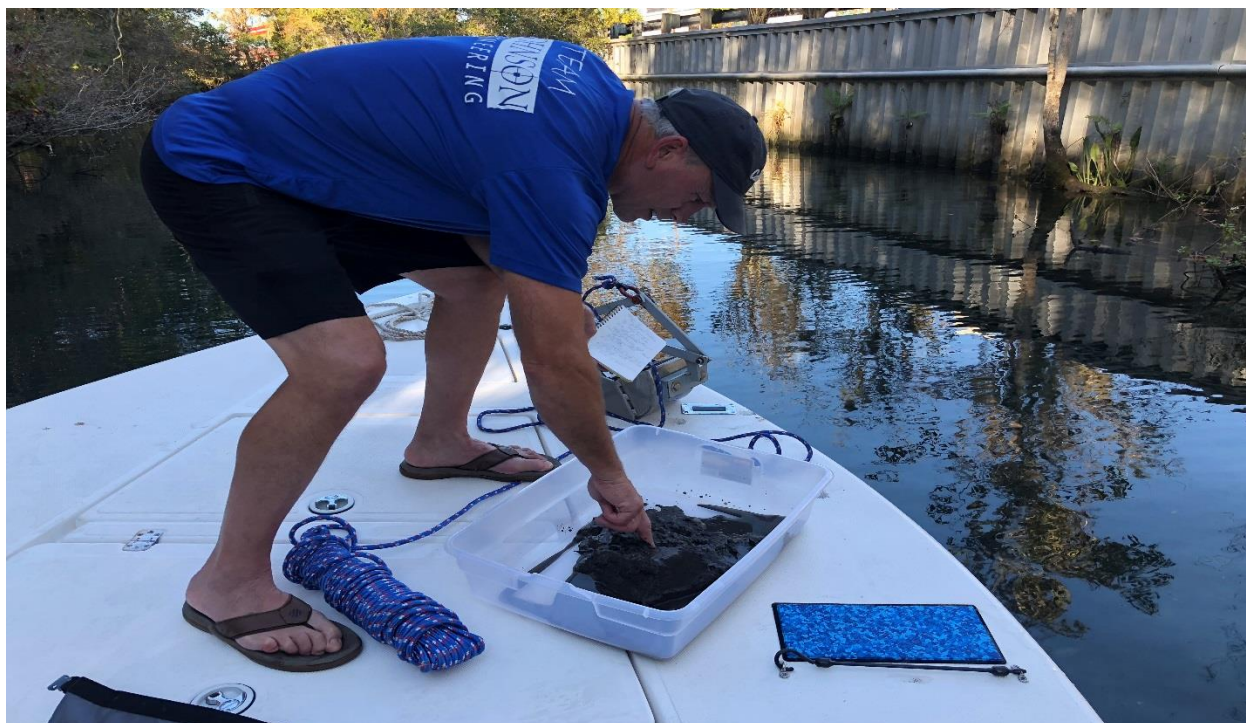
Site 1BE3. N: 28.5312 W: -82.3510. Depth - 4.5'

| King's Bay Ponar Sample Locations | | | Estimated Percent (%) Composition: petite Ponar | | | | | | | | | | |
|---|---|---|---|---|---|---|---|---|---|---|---|---|--|
| 1B E3 | 28.5312 | -82.351 | 4.5 | 50 | 50 | 0 | 0 | 0 | 0 | 0 | 0 | 0 | |

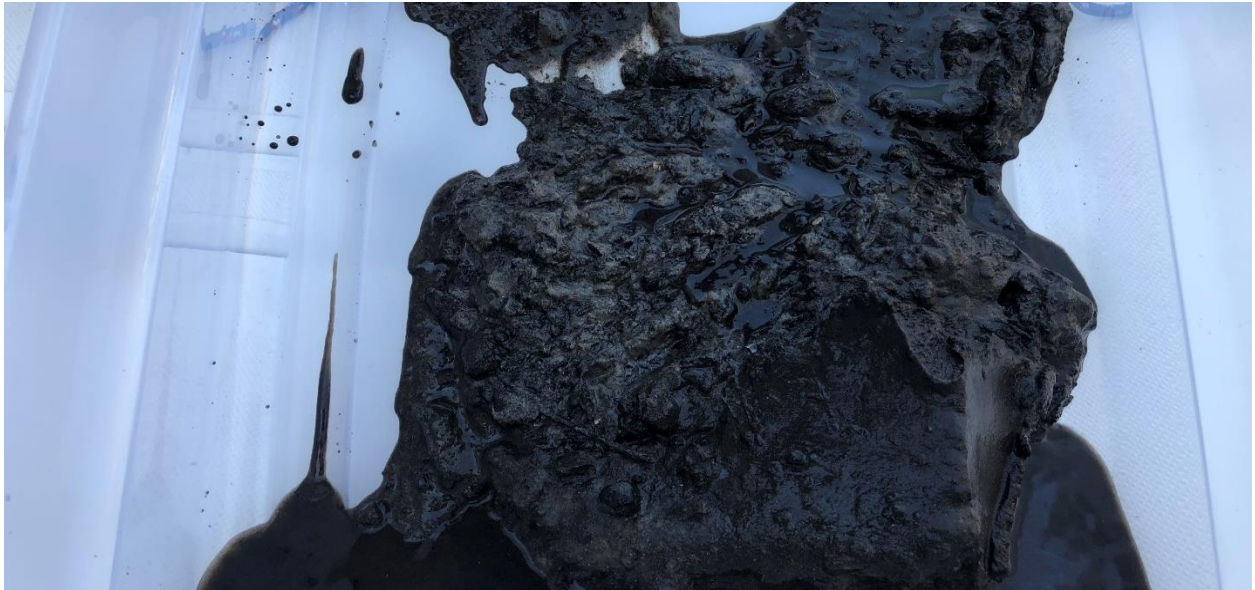
Site 1BE4. N: 28.5315 W: -82.3509. Depth - 4.5'

| King's Bay Ponar Sample Locations | | | Estimated Percent (%) Composition: petite Ponar | | | | | | | | | | |
|---|---|---|---|---|---|---|---|---|---|---|---|---|--|
| 1B E4 | 28.5315 | -82.3509 | 4.5 | 0 | 90 | 5 | 0 | 4 | 1 | 0 | 0 | 0 | |

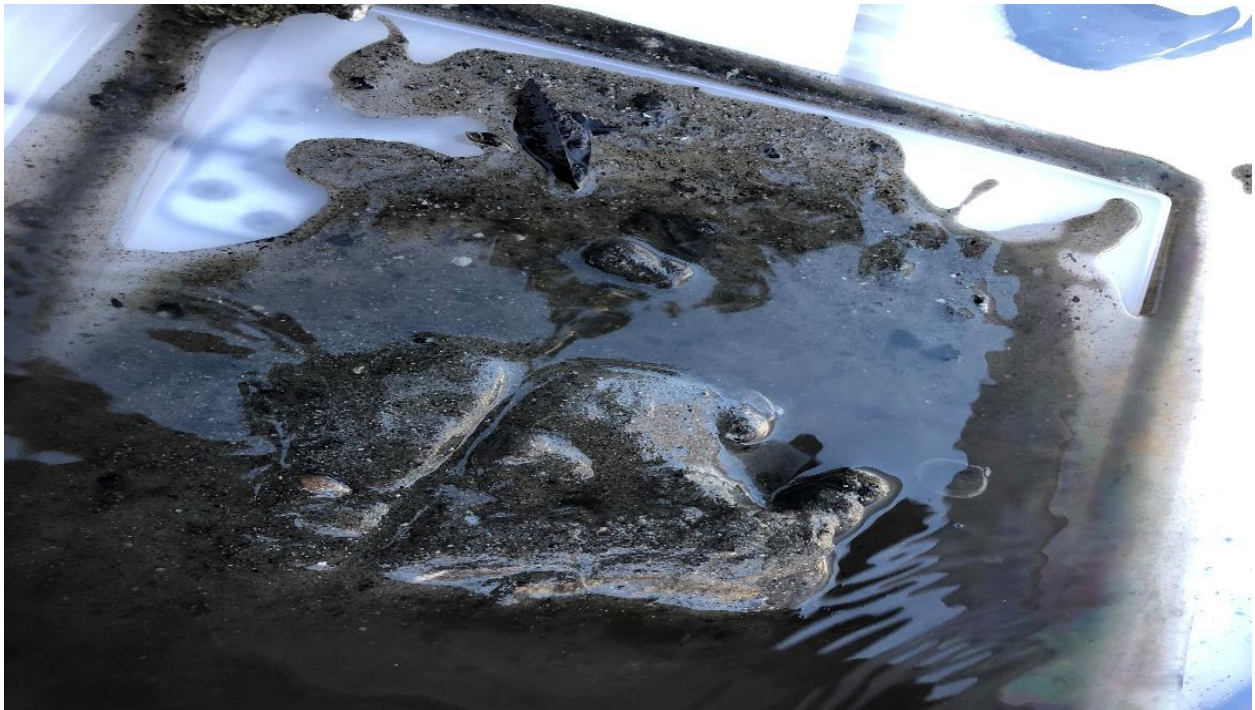
Site 1BE5. N: 28.5316 W: -82.3509. Depth - 3.0'

| King's Bay Ponar Sample Locations | | | Estimated Percent (%) Composition: petite Ponar | | | | | | | | | | |
|---|---|---|---|---|---|---|---|---|---|---|---|---|--|
| 1B E5 | 28.5316 | -82.3509 | 3 | 20 | 70 | 0 | 0 | 0 | 5 | 5 | 0 | 0 | |

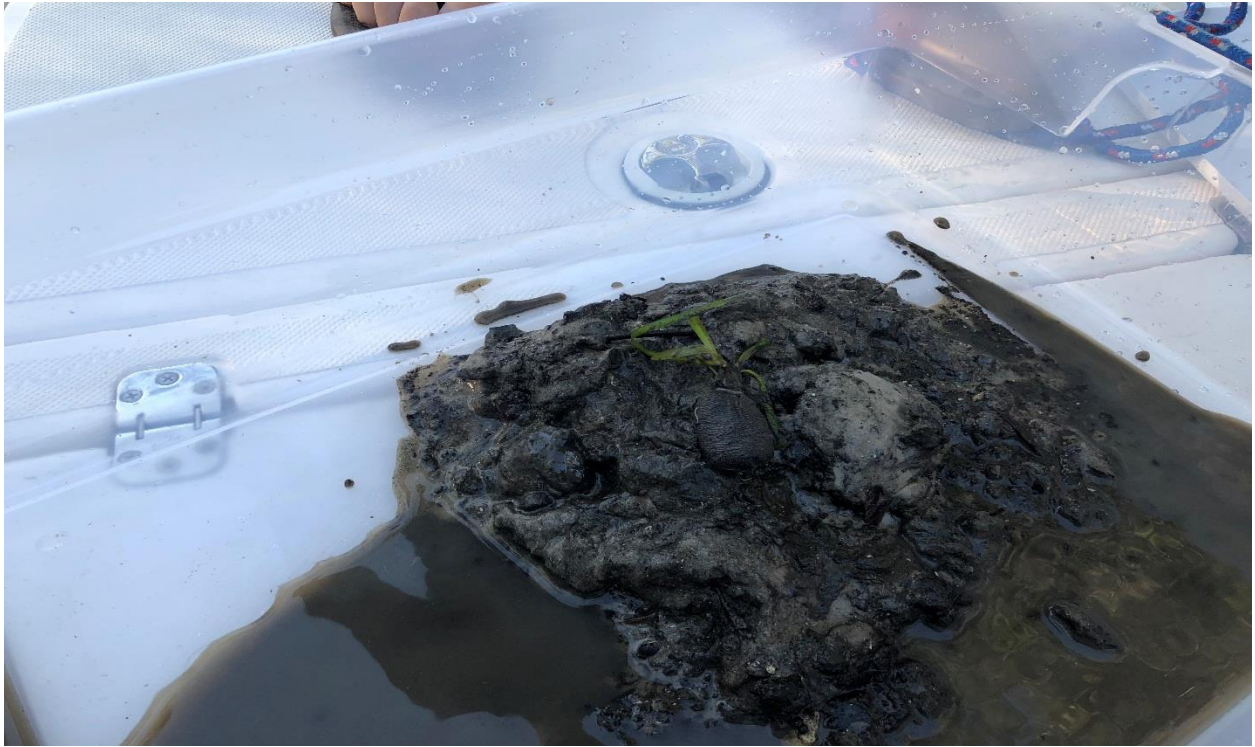
Site 1BE8. N: 28.5318 W: -82.3510. Depth - 5.3'

| King's Bay Ponar Sample Locations | | | Estimated Percent (%) Composition: petite Ponar | | | | | | | | | | |
|---|---|---|---|---|---|---|---|---|---|---|---|---|--|
| 1B E8 | 28.5318 | -82.351 | 5.3 | 85 | 10 | 0 | 0 | 0 | 0 | 5 | 0 | 0 | |

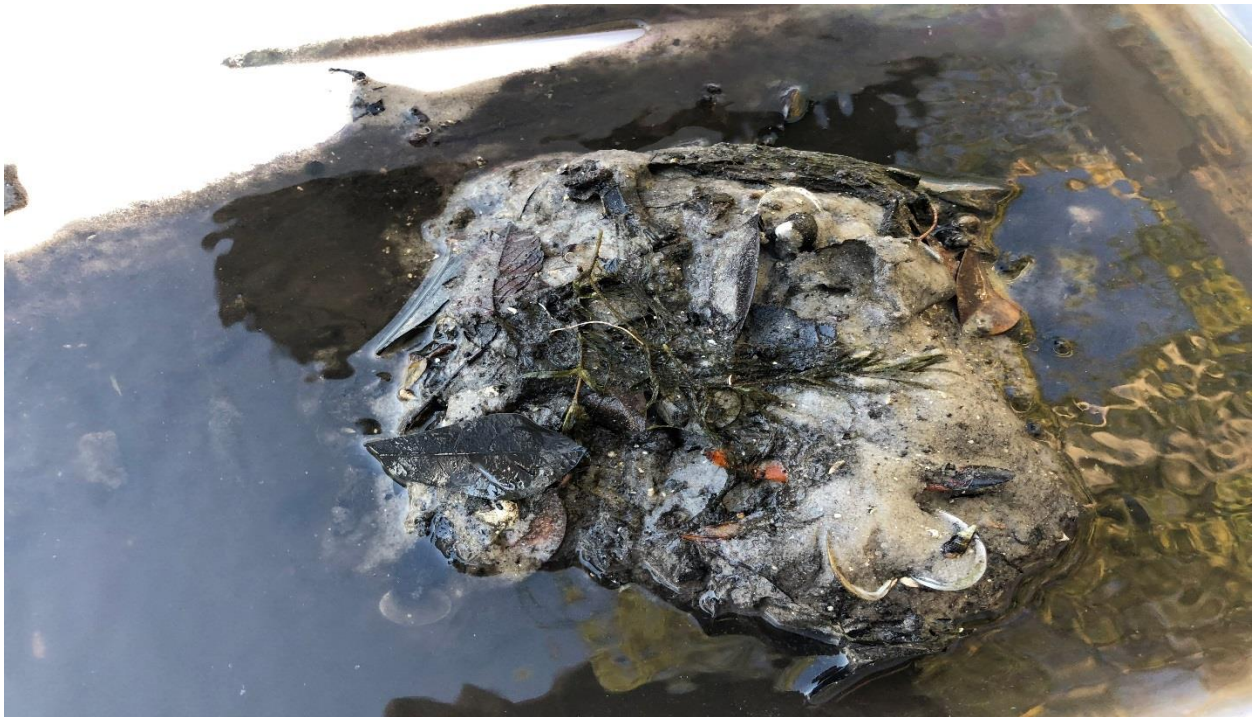
Site 1BE9. N: 28.5318 W: -82.3512. Depth - 4.0'

| King's Bay Ponar Sample Locations | | | Estimated Percent (%) Composition: petite Ponar | | | | | | | | | | |
|---|---|---|---|---|---|---|---|---|---|---|---|---|--|
| 1B E9 | 28.5318 | -82.3512 | 4 | 15 | 80 | 4 | 0 | 0 | 0 | 0 | 1 | 0 | |

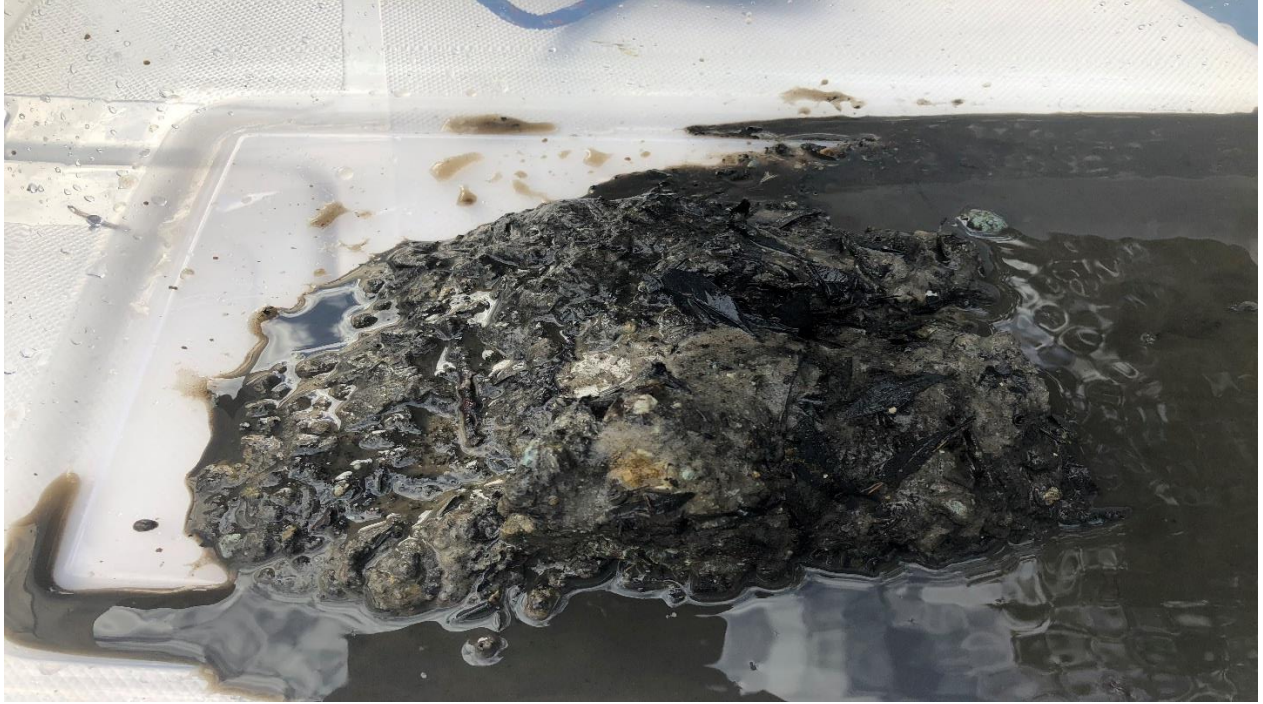
Site 1BE10. N: 28.5319 W: -82.3516. Depth - 2.5'

| King's Bay Ponar Sample Locations | | | Estimated Percent (%) Composition: petite Ponar | | | | | | | | | | |
|---|---|---|---|---|---|---|---|---|---|---|---|---|--|
| 1B E10 | 28.5319 | -82.3516 | 4 | 0 | 80 | 10 | 0 | 0 | 3 | 5 | 0 | 2 | |

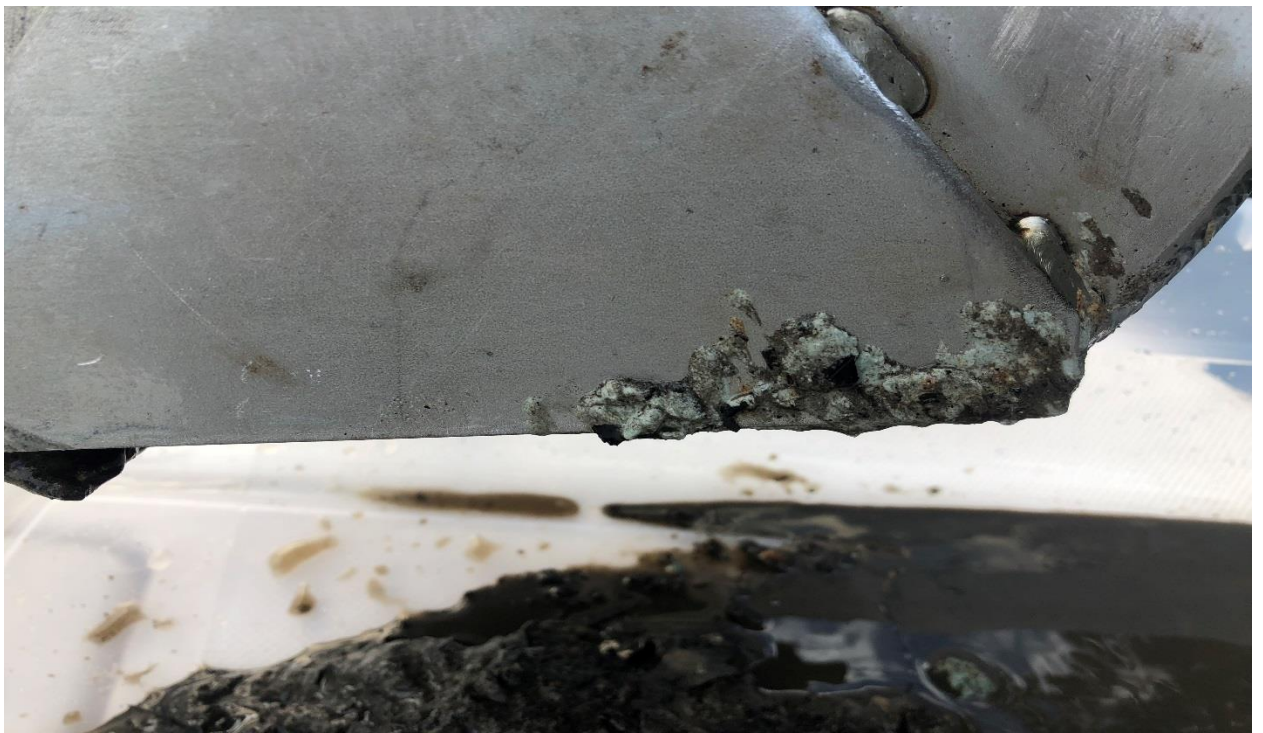
Site 1BW1. N: 28.5304 W: -82.3528. Depth - 9.7'

| King's Bay Ponar Sample Locations | | | Estimated Percent (%) Composition: petite Ponar | | | | | | | | | | |
|---|---|---|---|---|---|---|---|---|---|---|---|---|--|
| 1B W1 | 28.5304 | -82.3528 | 9.7 | 15 | 70 | 0.5 | 14.5 | 0 | 0 | 0 | 0 | 0 | |

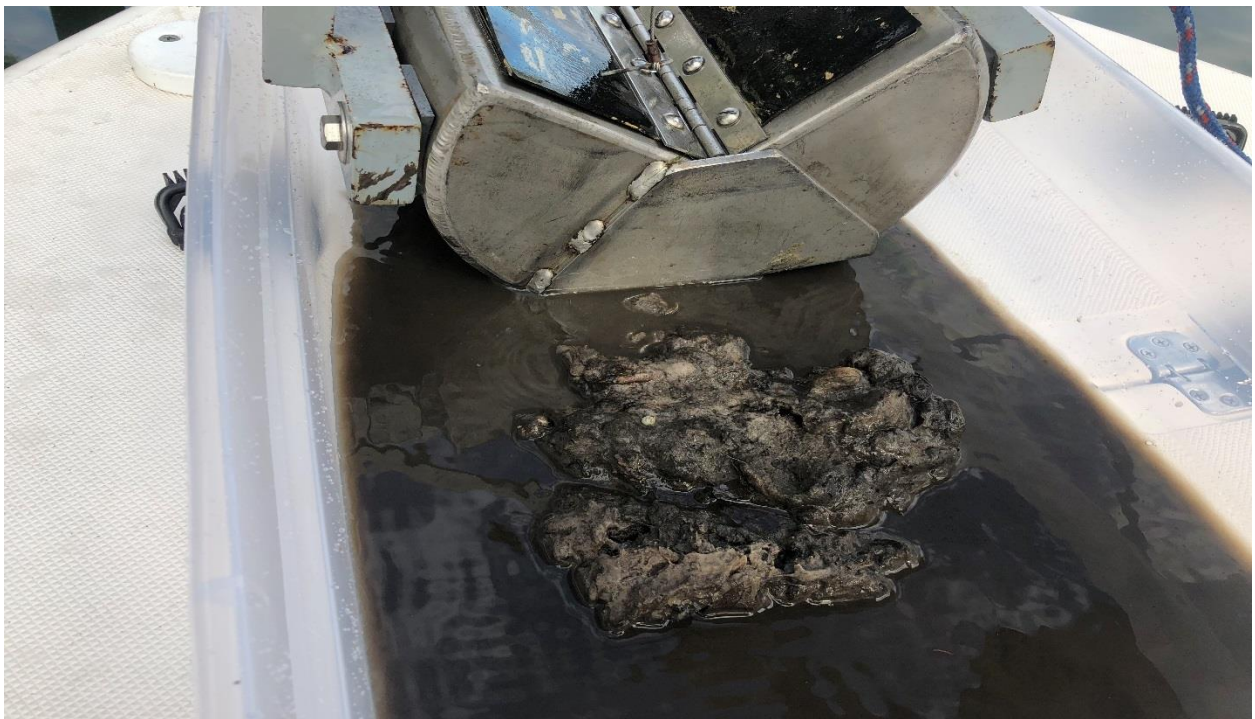
Site 1BW2. N: 28.5307 W: -82.3528. Depth - 5.6'

| King's Bay Ponar Sample Locations | | | Estimated Percent (%) Composition: petite Ponar | | | | | | | | | | |
|---|---|---|---|---|---|---|---|---|---|---|---|---|--|
| 1B W2 | 28.5307 | -82.3528 | 5.6 | 70 | 20 | 10 | 0 | 0 | 0 | 0 | 0 | 0 | |

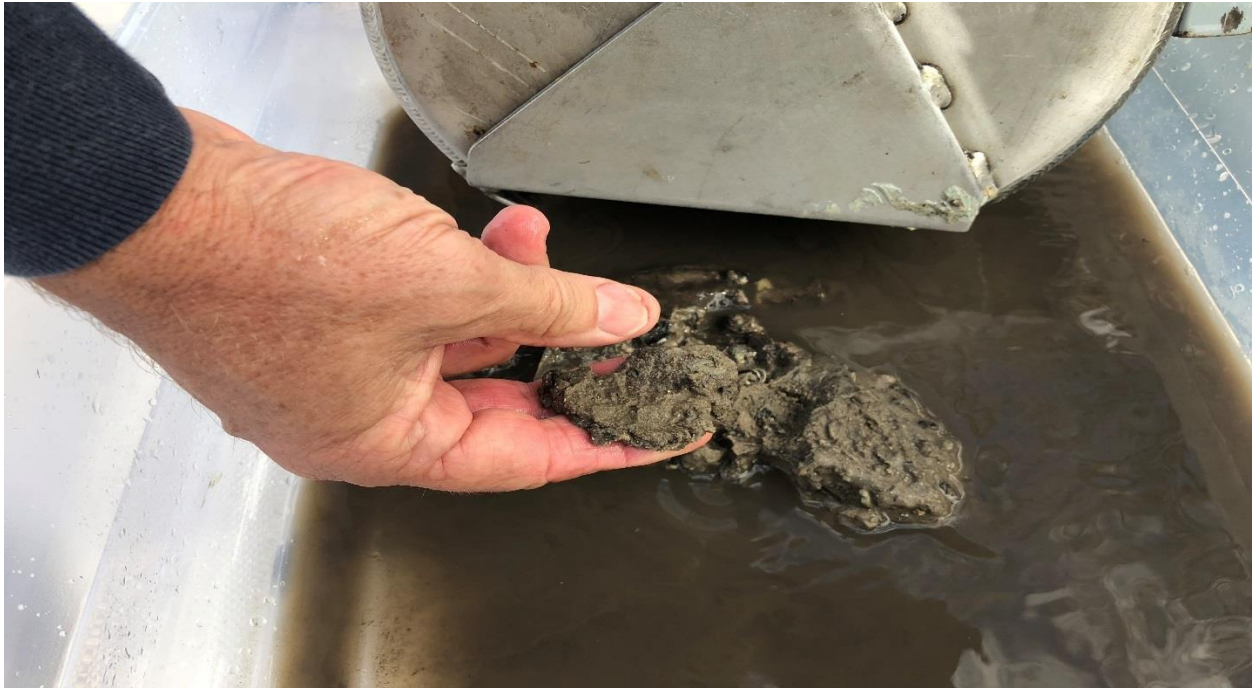
Site 1BW3. N: 28.5308 W: -82.3529. Depth - 6.0'

| King's Bay Ponar Sample Locations | | | Estimated Percent (%) Composition: petite Ponar | | | | | | | | | | |
|---|---|---|---|---|---|---|---|---|---|---|---|---|--|
| 1B W3 | 28.5308 | -82.3529 | 6 | 35 | 60 | 5 | 0 | 0 | 0 | 0 | 0 | 0 | |

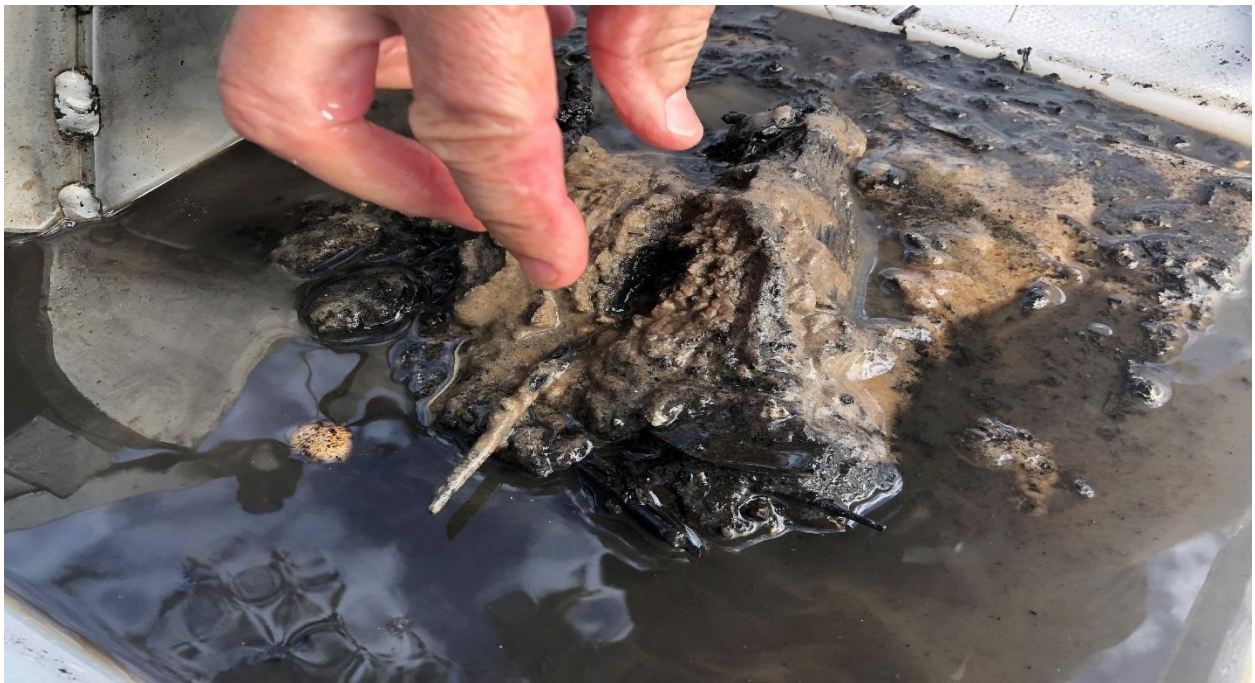
Site 1BW4. N: 28.5311 W: -82.3528. Depth - 10.0'

| King's Bay Ponar Sample Locations | | | Estimated Percent (%) Composition: petite Ponar | | | | | | | | | | |
|---|---|---|---|---|---|---|---|---|---|---|---|---|--|
| 1B W4 | 28.5311 | -82.3528 | 10 | 2 | 60 | 3 | 35 | 0 | 0 | 0 | 0 | 0 | |
